Access Compliance Report

Public Rights-of-Way

(Curb Ramps)

Intersection ID: 29959	Main Street: STATESVILLE_RD	Cross Street: SMITH_CORNERS_BV	Location: NE
ADA ID: 8964A5973A4C	Ramp Type: Perp	Initial Pass/Fail: Fail	Overall Compliance: No
Severity Score: 12.5			
Codes/Mitigation Info/Possible Solution		Field Measurements/Component Compliance

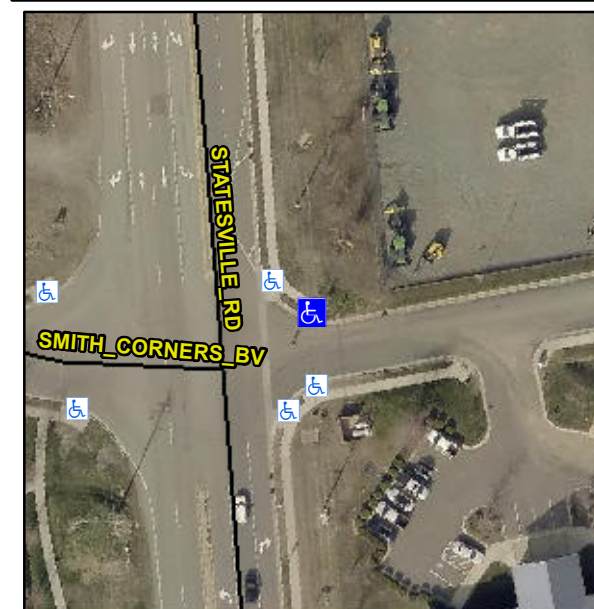
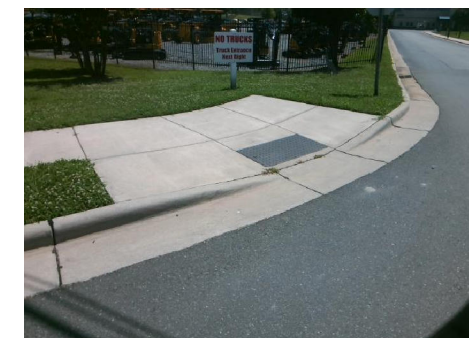
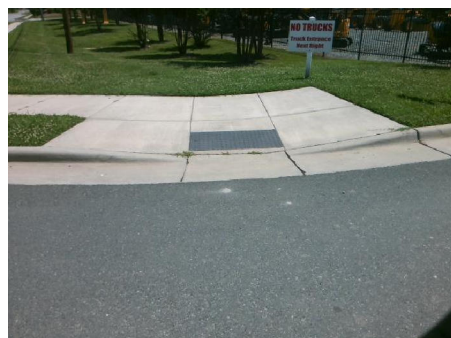
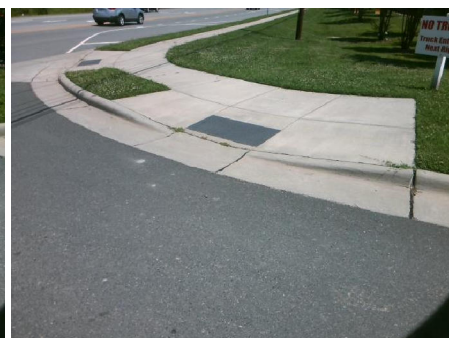
Compliance	Description	Data	Compliance	Description	Data
N/A	Ramp Length (in)	47.0	No	Ramp Slope (%)	10.4
Yes	Ramp Width (in)	48.0	Yes	Ramp XSlope (%)	2.0
N/A	Flare Type LT	N/A	N/A	Flare Type RT	N/A
N/A	Flare Slope LT (%)	N/A	N/A	Flare Slope RT (%)	N/A
N/A	Flare Traversable LT?	N/A	N/A	Flare Traversable RT?	N/A
N/A	Landing Length (in)	N/A	N/A	DWS Provided?	N/A
N/A	Landing Width (in)	N/A	N/A	DWS Contrast?	N/A
N/A	Landing Slope (%)	N/A	N/A	DWS Length (in)	N/A
N/A	Landing X Slope (%)	N/A	N/A	DWS Full Width?	N/A
N/A	Landing Curb? (Y/N)	N/A	N/A	DWS Offset (in)	N/A
N/A	Shared Landing?	N/A			
N/A	Gutter Ponding?	N/A	N/A	Gutter Slope (%)	N/A
N/A	Gutter Lip Ht (in)	N/A	N/A	Gutter X Slope (%)	N/A
N/A	Painted X Walk1?	No	N/A	Painted X Walk2?	N/A
	X Walk 1 Direction	To S		X Walk 2 Direction	N/A
N/A	X Walk 1 Width (in)	N/A	N/A	X Walk 2 Width (in)	N/A
	X Walk 1 Slope (%)	0.9		X Walk 2 Slope (%)	N/A
	X Walk 1 X Slope (%)	1.8		X Walk 2 X Slope (%)	N/A

N/A	Ramp inside XWalk1?	N/A	N/A	Ramp inside XWalk2?	N/A
	Road Slope (%)	N/A	N/A	Clear Space?	N/A
	Road X Slope (%)	N/A	N/A	Clear Space to XWalk (in)	N/A
N/A	Any Obstructions?	N/A	N/A	Storm Grate/Utility Hazard?	N/A
	Obstruction Type			Storm Grate/Utility Type	
		N/A			N/A
			Yes	Surface Condition? (G/P)	Good

Remove & Replace Entire Ramp.

R304.2.2
