Access Compliance Report

Public Rights-of-Way

(Curb Ramps)

Intersection ID: 28226	Main Street: CADBURY_CT	Cross Street: DARBY_CHASE_DR	Location: NE
ADA ID: 8969B134880F	Ramp Type: Perp	Initial Pass/Fail: Fail	Overall Compliance: No
Severity Score: 10			
Codes/Mitigation Info/Possible Solution		Field Measurements/Component Compliance

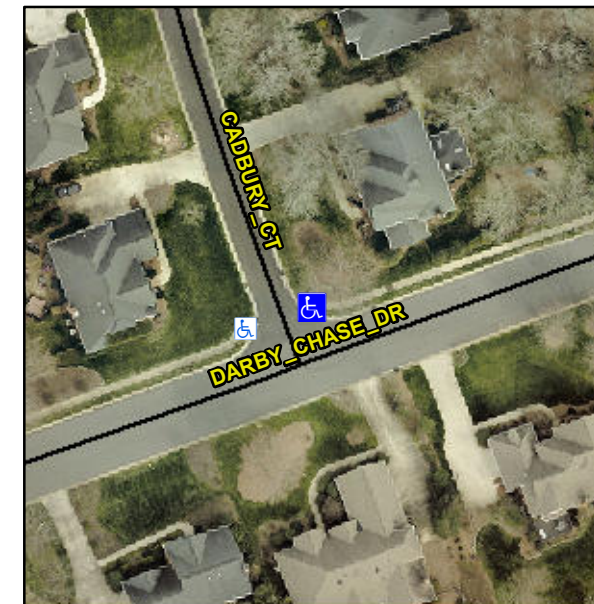
Not Found, R304.5.1, R304.5.3

Compliance	Description	Data	Compliance	Description	Data
N/A	Ramp Length (in)	48.0	Yes	Ramp Slope (%)	7.1
No	Ramp Width (in)	43.0	No	Ramp XSlope (%)	2.1
N/A	Flare Type LT	N/A	N/A	Flare Type RT	N/A
N/A	Flare Slope LT (%)	N/A	N/A	Flare Slope RT (%)	N/A
N/A	Flare Traversable LT?	N/A	N/A	Flare Traversable RT?	N/A
N/A	Landing Length (in)	N/A	N/A	DWS Provided?	N/A
N/A	Landing Width (in)	N/A	N/A	DWS Contrast?	N/A
N/A	Landing Slope (%)	N/A	N/A	DWS Length (in)	N/A
N/A	Landing X Slope (%)	N/A	N/A	DWS Full Width?	N/A
N/A	Landing Curb? (Y/N)	N/A	N/A	DWS Offset (in)	N/A
N/A	Shared Landing?	N/A			
N/A	Gutter Ponding?	N/A	N/A	Gutter Slope (%)	N/A
N/A	Gutter Lip Ht (in)	0.5	N/A	Gutter X Slope (%)	N/A
N/A	Painted X Walk1?	No	N/A	Painted X Walk2?	N/A
	X Walk 1 Direction	To SW		X Walk 2 Direction	N/A
N/A	X Walk 1 Width (in)	N/A	N/A	X Walk 2 Width (in)	N/A
	X Walk 1 Slope (%)	0.3		X Walk 2 Slope (%)	N/A
	X Walk 1 X Slope (%)	2.3		X Walk 2 X Slope (%)	N/A

Remove & Replace Entire Ramp.
