## **Access Compliance Report Public Rights-of-Way** (Curb Ramps)

Main Street: ALLEGHANY\_ST Intersection ID: 10749 Cross Street: FREEDOM\_DR Location: W **Overall Compliance: No** ADA ID: 896B32FA174E Ramp Type: Perp Initial Pass/Fail: Fail **Severity Score:** 8.75

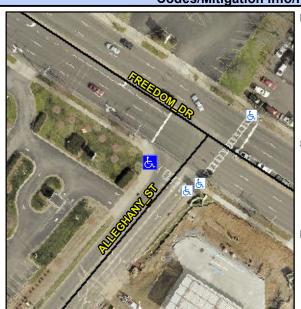
Field Measurements/Component Compliance						
Compliance Description		Data	Comp	liance Description	Data	
N/A	Ramp Length (in)	92.5	Yes	Ramp Slope (%)	5.8	
No	Ramp Width (in)	47.0	Yes	Ramp XSlope (%)	1.2	
N/A	Flare Type LT	N/A	N/A	Flare Type RT	N/A	
N/A	Flare Slope LT (%)	N/A	N/A	Flare Slope RT (%)	N/A	
N/A	Flare Traversable LT?	N/A	N/A	Flare Traversable RT?	N/A	
N/A	Landing Length (in)	N/A	N/A	DWS Provided?	N/A	
N/A	Landing Width (in)	N/A	N/A	DWS Contrast?	N/A	
N/A	Landing Slope (%)	N/A	N/A	DWS Length (in)	N/A	
N/A	Landing X Slope (%)	N/A	N/A	DWS Full Width?	N/A	
N/A	Landing Curb? (Y/N)	N/A	N/A	DWS Offset (in)	N/A	
N/A	Shared Landing?	N/A				
N/A	Gutter Ponding?	N/A	N/A	Gutter Slope (%)	N/A	
N/A	Gutter Lip Ht (in)	N/A	N/A	Gutter X Slope (%)	N/A	
N/A	Painted X Walk1?	Yes	N/A	Painted X Walk2?	N/A	
	X Walk 1 Direction	To SE		X Walk 2 Direction	N/A	
N/A	X Walk 1 Width (in)	102.0	N/A	X Walk 2 Width (in)	N/A	
	X Walk 1 Slope (%)	0.2		X Walk 2 Slope (%)	N/A

X Walk 1 X Slope (%)	0.0		X Walk 2 X Slope (%)	N/A	
N/A	Ramp inside XWalk1?	Yes	N/A	Ramp inside XWalk2?	N/A	
	Road Slope (%)	N/A	N/A	Clear Space?	N/A	
	Road X Slope (%)	N/A	N/A	Clear Space to XWalk (in)	N/A	
N/A	Any Obstructions?	N/A	N/A	Storm Grate/Utility Hazard?	N/A	
	Obstruction Type			Storm Grate/Utility Type		
		N/A			N/A	
			Yes	Surface Condition? (G/P)	Good	
	The state of the s

Possible Solutions:	9		
Remove & Replace Entire Ramp.			
	N		
	N		
	N		
	1		
	1		
Surveyor Notes:	ı		
N/A	1		
	1		
	1		
	1		
PROW/ADA:	1		
Not Found, R304.5.1	N		
	1		
	1
