Access Compliance Report

Public Rights-of-Way

(Curb Ramps)

Intersection ID: 12278	Main Street: SEIGLE_AV	Cross Street: VAN_EVERY_ST	Location: E
ADA ID: 896B792B09D3	Ramp Type: Perp	Initial Pass/Fail: Fail	Overall Compliance: No
		Severity Score: 12.5

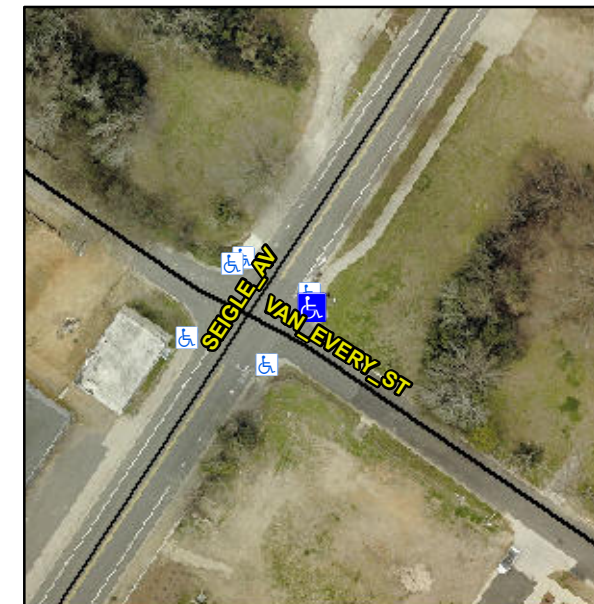
Not Found, R304.2.2

Compliance	Description	Data	Compliance	Description	Data
N/A	Ramp Length (in)	71.5	No	Ramp Slope (%)	10.1
Yes	Ramp Width (in)	53.0	Yes	Ramp XSlope (%)	0.7
N/A	Flare Type LT	N/A	N/A	Flare Type RT	N/A
N/A	Flare Slope LT (%)	N/A	N/A	Flare Slope RT (%)	N/A
N/A	Flare Traversable LT?	N/A	N/A	Flare Traversable RT?	N/A
N/A	Landing Length (in)	N/A	N/A	DWS Provided?	N/A
N/A	Landing Width (in)	N/A	N/A	DWS Contrast?	N/A
N/A	Landing Slope (%)	N/A	N/A	DWS Length (in)	N/A
N/A	Landing X Slope (%)	N/A	N/A	DWS Full Width?	N/A
N/A	Landing Curb? (Y/N)	N/A	N/A	DWS Offset (in)	N/A
N/A	Shared Landing?	N/A			
N/A	Gutter Ponding?	N/A	N/A	Gutter Slope (%)	N/A
N/A	Gutter Lip Ht (in)	N/A	N/A	Gutter X Slope (%)	N/A
N/A	Painted X Walk1?	No	N/A	Painted X Walk2?	N/A
	X Walk 1 Direction	To SW		X Walk 2 Direction	N/A
N/A	X Walk 1 Width (in)	N/A	N/A	X Walk 2 Width (in)	N/A
	X Walk 1 Slope (%)	5.0		X Walk 2 Slope (%)	N/A
	X Walk 1 X Slope (%)	3.1		X Walk 2 X Slope (%)	N/A

Remove & Replace Entire Ramp.
