Access Compliance Report

Public Rights-of-Way

(Curb Ramps)

Intersection ID: 10031200	Main Street: MARLENE_ST	Cross Street: N/A	Location: E
ADA ID: 898B71B26FB8	Ramp Type: Perp	Initial Pass/Fail: Fail	Overall Compliance: No
Codes/Mitigation Info/Possible Solution		Field Measurements/Component Compliance	
Severity Score: 33.75

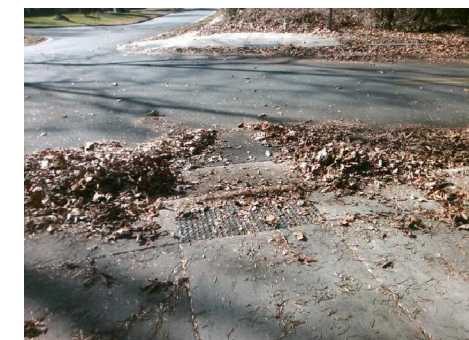
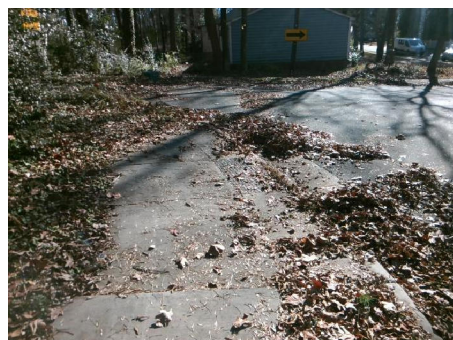
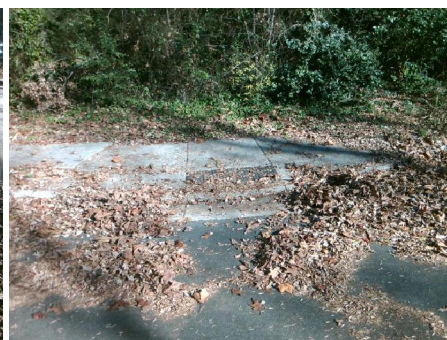
Not Found, R304.5.1, R304.2.2, R304.5.3

Compliance	Description	Data	Compliance	Description	Data
N/A	Ramp Length (in)	27.0	No	Ramp Slope (%)	8.5
No	Ramp Width (in)	47.0	No	Ramp XSlope (%)	6.4
N/A	Flare Type LT	N/A	N/A	Flare Type RT	N/A
N/A	Flare Slope LT (%)	N/A	N/A	Flare Slope RT (%)	N/A
N/A	Flare Traversable LT?	N/A	N/A	Flare Traversable RT?	N/A
N/A	Landing Length (in)	N/A	N/A	DWS Provided?	N/A
N/A	Landing Width (in)	N/A	N/A	DWS Contrast?	N/A
N/A	Landing Slope (%)	N/A	N/A	DWS Length (in)	N/A
N/A	Landing X Slope (%)	N/A	N/A	DWS Full Width?	N/A
N/A	Landing Curb? (Y/N)	N/A	N/A	DWS Offset (in)	N/A
N/A	Shared Landing?	N/A			
N/A	Gutter Ponding?	N/A	N/A	Gutter Slope (%)	N/A
N/A	Gutter Lip Ht (in)	N/A	N/A	Gutter X Slope (%)	N/A
N/A	Painted X Walk1?	No	N/A	Painted X Walk2?	N/A
	X Walk 1 Direction	To W		X Walk 2 Direction	N/A
N/A	X Walk 1 Width (in)	N/A	N/A	X Walk 2 Width (in)	N/A
	X Walk 1 Slope (%)	0.9		X Walk 2 Slope (%)	N/A
	X Walk 1 X Slope (%)	5.6		X Walk 2 X Slope (%)	N/A

N/A	Ramp inside XWalk1?	N/A	N/A	Ramp inside XWalk2?	N/A
	Road Slope (%)	N/A	N/A	Clear Space?	N/A
	Road X Slope (%)	N/A	N/A	Clear Space to XWalk (in)	N/A
N/A	Any Obstructions?	N/A	N/A	Storm Grate/Utility Hazard?	N/A
	Obstruction Type			Storm Grate/Utility Type	
		N/A			N/A
			Yes	Surface Condition? (G/P)	Good

Remove & Replace Entire Ramp.
