## **Access Compliance Report Public Rights-of-Way** (Curb Ramps)

Intersection ID: 15543 Main Street: EXECUTIVE CENTER DR **Cross Street: HOLLINS DR** Location: NW **ADA ID: 898C25CBAB2D** Ramp Type: PerpDiag Initial Pass/Fail: Fail **Overall Compliance: No** Severity Score: 33.75

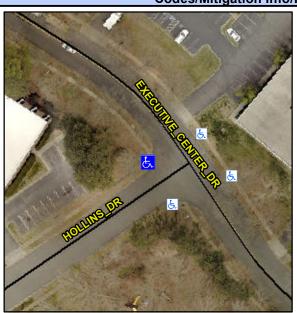
Field Measurements/Component Compliance						
	Compliance Description		Data	Comp	oliance Description	Data
	N/A	Ramp Length (in)	80.0	No	Ramp Slope (%)	14.1
	No	Ramp Width (in)	42.0	Yes	Ramp XSlope (%)	1.2
	N/A	Flare Type LT	N/A	N/A	Flare Type RT	N/A
	N/A	Flare Slope LT (%)	N/A	N/A	Flare Slope RT (%)	N/A
	N/A	Flare Traversable LT?	N/A	N/A	Flare Traversable RT?	N/A
	N/A	Landing Length (in)	N/A	N/A	DWS Provided?	N/A
	N/A	Landing Width (in)	N/A	N/A	DWS Contrast?	N/A
	N/A	Landing Slope (%)	N/A	N/A	DWS Length (in)	N/A
	N/A	Landing X Slope (%)	N/A	N/A	DWS Full Width?	N/A
	N/A	Landing Curb? (Y/N)	N/A	N/A	DWS Offset (in)	N/A
	N/A	Shared Landing?	N/A			
	N/A	Gutter Ponding?	N/A	N/A	Gutter Slope (%)	N/A
	N/A	Gutter Lip Ht (in)	N/A	N/A	Gutter X Slope (%)	N/A
	N/A	Painted X Walk1?	No	N/A	Painted X Walk2?	No
		X Walk 1 Direction	To SE		X Walk 2 Direction	To NE
	N/A	X Walk 1 Width (in)	N/A	N/A	X Walk 2 Width (in)	N/A
		X Walk 1 Slope (%)	2.3		X Walk 2 Slope (%)	7.5

X Walk 1 X Slope (%)	1.6		X Walk 2 X Slope (%)	0.2
	N/A	Ramp inside XWalk1?	N/A	N/A	Ramp inside XWalk2?	N/A
		Road Slope (%)	1.0	N/A	Clear Space?	N/A
		Road X Slope (%)	1.6	N/A	Clear Space to XWalk (in)	N/A
	N/A	Any Obstructions?	N/A	N/A	Storm Grate/Utility Hazard?	N/A
		Obstruction Type			Storm Grate/Utility Type	
			N/A			N/A
				Yes	Surface Condition? (G/P)	Good

Possible Solutions: **Remove & Replace Curb Ramp With** Two New Directional Ramps or Equivalent. Surveyor Notes: N/A PROW/ADA: Not Found, R304.5.1, R304.2.2
