# Access Compliance Report

## Public Rights-of-Way

### (Curb Ramps)

Intersection ID: 10031127	Main Street: MARGARET_WALLACE_RD	Cross Street: N/A	Location: NE
ADA ID: 898CF71108FF	Ramp Type: PerpDiag	Initial Pass/Fail: Fail	Overall Compliance: No
Severity Score: 48.75			
Codes/Mitigation Info/Possible Solution		Field Measurements/Component Compliance

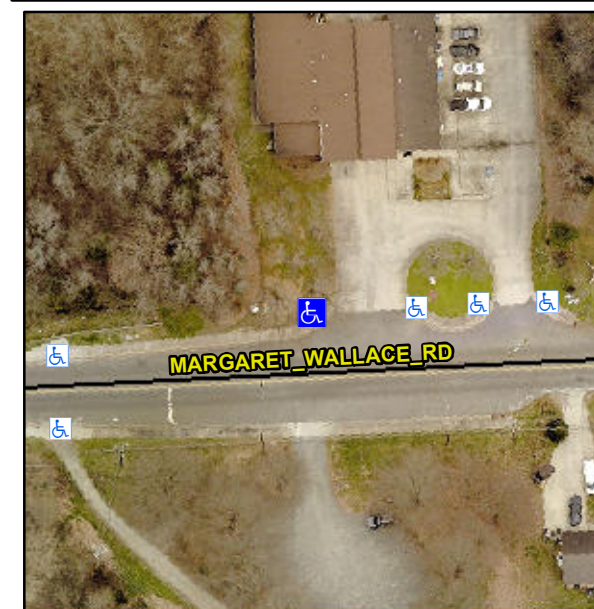
**Not Found, R304.5.1, R304.2.2**

Compliance	Description	Data	Compliance	Description	Data
N/A	Ramp Length (in)	60.0	No	Ramp Slope (%)	10.0
No	Ramp Width (in)	24.0	Yes	Ramp XSlope (%)	2.7
N/A	Flare Type LT	N/A	N/A	Flare Type RT	N/A
N/A	Flare Slope LT (%)	N/A	N/A	Flare Slope RT (%)	N/A
N/A	Flare Traversable LT?	N/A	N/A	Flare Traversable RT?	N/A
N/A	Landing Length (in)	N/A	N/A	DWS Provided?	N/A
N/A	Landing Width (in)	N/A	N/A	DWS Contrast?	N/A
N/A	Landing Slope (%)	N/A	N/A	DWS Length (in)	N/A
N/A	Landing X Slope (%)	N/A	N/A	DWS Full Width?	N/A
N/A	Landing Curb? (Y/N)	N/A	N/A	DWS Offset (in)	N/A
N/A	Shared Landing?	N/A			
N/A	Gutter Ponding?	N/A	N/A	Gutter Slope (%)	N/A
N/A	Gutter Lip Ht (in)	N/A	N/A	Gutter X Slope (%)	N/A
N/A	Painted X Walk1?	No	N/A	Painted X Walk2?	No
	X Walk 1 Direction	To S		X Walk 2 Direction	To W
N/A	X Walk 1 Width (in)	N/A	N/A	X Walk 2 Width (in)	N/A
	X Walk 1 Slope (%)	0.8		X Walk 2 Slope (%)	3.1
	X Walk 1 X Slope (%)	1.3		X Walk 2 X Slope (%)	0.8

N/A	Ramp inside XWalk1?	N/A	N/A	Ramp inside XWalk2?	N/A
	Road Slope (%)	3.2	N/A	Clear Space?	N/A
	Road X Slope (%)	0.1	N/A	Clear Space to XWalk (in)	N/A
N/A	Any Obstructions?	N/A	N/A	Storm Grate/Utility Hazard?	N/A
	Obstruction Type			Storm Grate/Utility Type	
		N/A			N/A
			Yes	Surface Condition? (G/P)	Good

**Remove & Replace Curb Ramp With Two New Directional Ramps or Equivalent.**
