# Access Compliance Report

## Public Rights-of-Way

### (Curb Ramps)

Intersection ID: 3373	Main Street: KATELYN_DR	Cross Street: PROSPERITY_CHURCH_RD	Location: E
ADA ID: 899495CF69EB	Ramp Type: Combination1	Initial Pass/Fail: Fail	Overall Compliance: No
Codes/Mitigation Info/Possible Solution		Field Measurements/Component Compliance	
Severity Score: 26.25

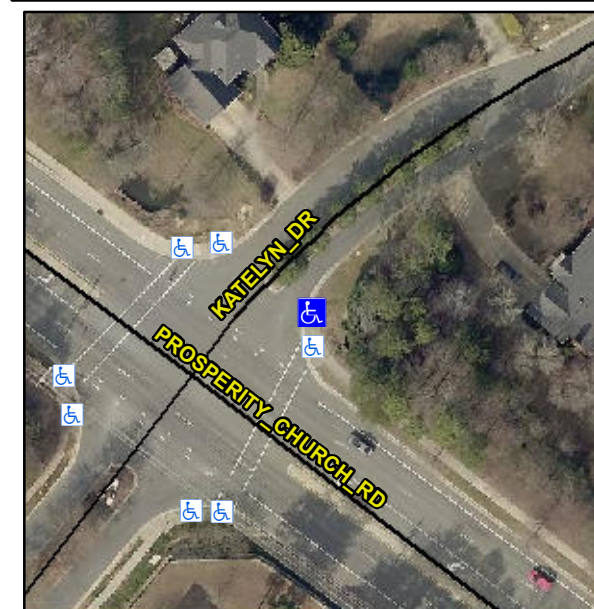
**LT RP < 5%**

**R304.2.2, R304.5.3, R304.3.2**

Compliance	Description	Data	Compliance	Description	Data
N/A	Ramp Length LT (in)	61.0	N/A	Ramp Length RT (in)	55.0
Yes	Ramp Width LT (in)	70.0	Yes	Ramp Width RT (in)	88.0
Yes	Ramp Slope LT (%)	1.1	No	Ramp Slope RT (%)	13.3
Yes	Ramp XSlope LT (%)	0.2	Yes	Ramp XSlope RT (%)	0.2
N/A	Ramp Length (in)	90.0	No	Ramp Slope (%)	18.4
Yes	Ramp Width (in)	56.0	No	Ramp XSlope (%)	3.9
N/A	Flare Type LT	N/A	N/A	Flare Type RT	N/A
N/A	Flare Slope LT (%)	N/A	N/A	Flare Slope RT (%)	N/A
N/A	Flare Traversable LT?	N/A	N/A	Flare Traversable RT?	N/A
N/A	Landing Length (in)	N/A	N/A	DWS Provided?	N/A
N/A	Landing Width (in)	N/A	N/A	DWS Contrast?	N/A
N/A	Landing Slope (%)	N/A	N/A	DWS Length (in)	N/A
N/A	Landing X Slope (%)	N/A	N/A	DWS Full Width?	N/A
N/A	Landing Curb? (Y/N)	N/A	N/A	DWS Offset (in)	N/A
N/A	Shared Landing?	N/A			
N/A	Gutter Ponding?	N/A	N/A	Gutter Slope (%)	N/A
N/A	Gutter Lip Ht (in)	N/A	N/A	Gutter X Slope (%)	N/A
N/A	Painted X Walk1?	No	N/A	Painted X Walk2?	N/A

**Remove & Replace Entire Ramp.**

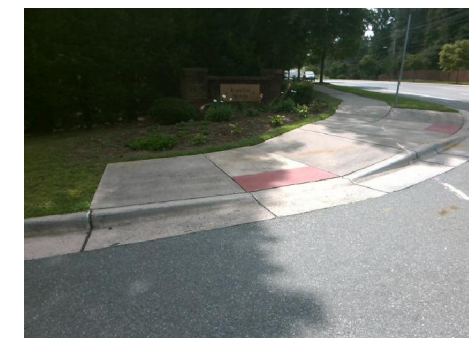
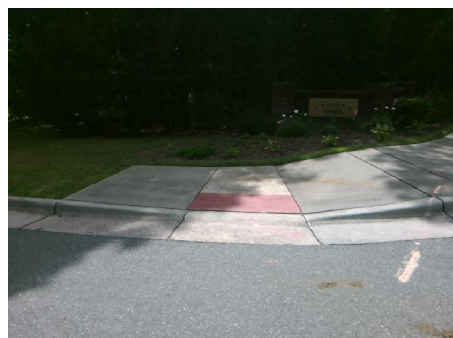
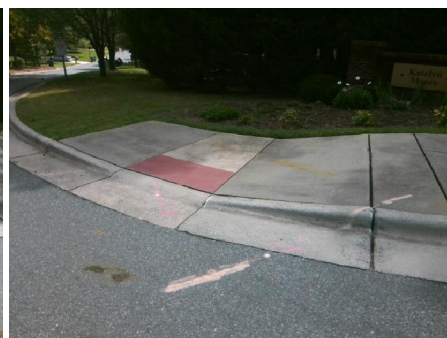
X Walk 1 Direction	To NW		X Walk 2 Direction	N/A
	X Walk 1 Width (in)	N/A		X Walk 2 Width (in)	N/A
	X Walk 1 Slope (%)	1.7		X Walk 2 Slope (%)	N/A
	X Walk 1 X Slope (%)	4.1		X Walk 2 X Slope (%)	N/A
N/A	Ramp inside XWalk1?	N/A	N/A	Ramp inside XWalk2?	N/A
	Road Slope (%)	N/A		Clear Space?	N/A
	Road X Slope (%)	N/A	N/A	Clear Space to XWalk (in)	N/A
			N/A	Any Obstruction?	N/A
				Obstruction Type	N/A
			N/A	Storm Grate/Utility Hazard?	N/A
				Storm Grate/Utility Type	N/A
			Yes	Surface Condition? (G/P)	Good
				Curb Slope (%)	N/A
