# Access Compliance Report

## Public Rights-of-Way

Intersection ID: 9440	Main Street: BRADFORD_DR	Cross Street: EDGEWOOD_RD	Location: E
ADA ID: 899C6ADFDB0F	Ramp Type: Perp	Initial Pass/Fail: Fail	Overall Compliance: No
		Severity Score: 12.5

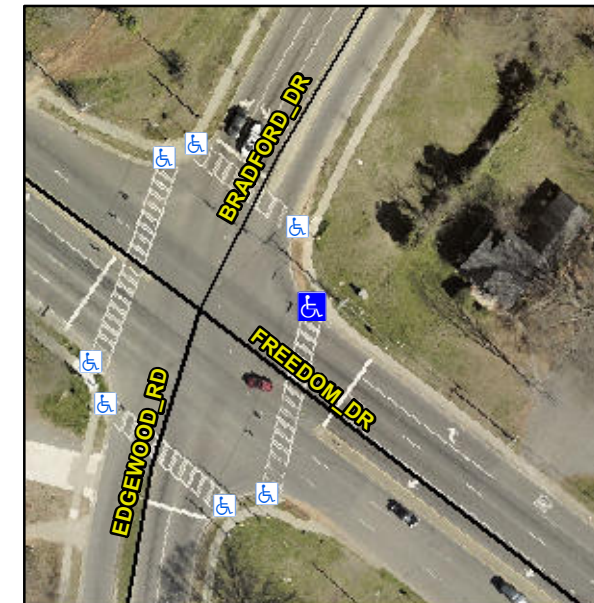
**Not Found, R304.2.2**

Compliance	Description	Data	Compliance	Description	Data
N/A	Ramp Length (in)	60.0	No	Ramp Slope (%)	9.2
Yes	Ramp Width (in)	48.0	Yes	Ramp XSlope (%)	0.3
N/A	Flare Type LT	N/A	N/A	Flare Type RT	N/A
N/A	Flare Slope LT (%)	N/A	N/A	Flare Slope RT (%)	N/A
N/A	Flare Traversable LT?	N/A	N/A	Flare Traversable RT?	N/A
N/A	Landing Length (in)	N/A	N/A	DWS Provided?	N/A
N/A	Landing Width (in)	N/A	N/A	DWS Contrast?	N/A
N/A	Landing Slope (%)	N/A	N/A	DWS Length (in)	N/A
N/A	Landing X Slope (%)	N/A	N/A	DWS Full Width?	N/A
N/A	Landing Curb? (Y/N)	N/A	N/A	DWS Offset (in)	N/A
N/A	Shared Landing?	N/A			
N/A	Gutter Ponding?	N/A	N/A	Gutter Slope (%)	N/A
N/A	Gutter Lip Ht (in)	N/A	N/A	Gutter X Slope (%)	N/A
N/A	Painted X Walk1?	Yes	N/A	Painted X Walk2?	N/A
	X Walk 1 Direction	To SW		X Walk 2 Direction	N/A
N/A	X Walk 1 Width (in)	124.0	N/A	X Walk 2 Width (in)	N/A
	X Walk 1 Slope (%)	2.0		X Walk 2 Slope (%)	N/A
	X Walk 1 X Slope (%)	0.3		X Walk 2 X Slope (%)	N/A

**Remove & Replace Entire Ramp.**
