# Access Compliance Report

## Public Rights-of-Way

### (Curb Ramps)

Intersection ID: 24399	Main Street: SUMMERLIN_PL	Cross Street: WINDYRUSH_RD	Location: SW
ADA ID: 899D49D07C75	Ramp Type: PerpDiag	Initial Pass/Fail: Fail	Overall Compliance: No
Severity Score: 25			
Codes/Mitigation Info/Possible Solution		Field Measurements/Component Compliance

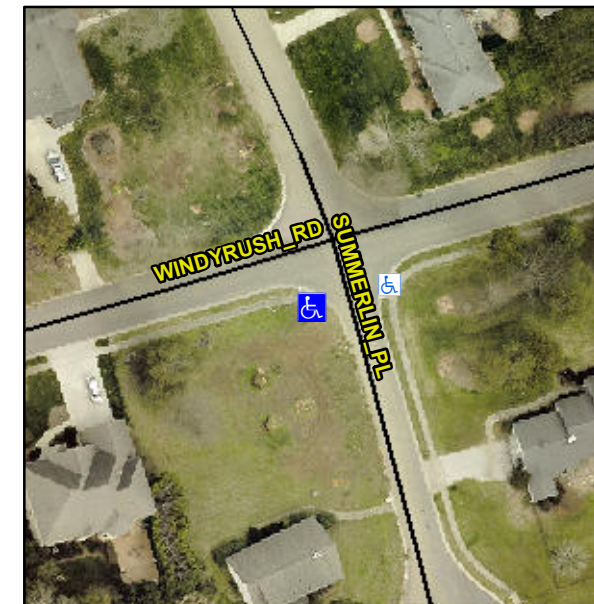
Compliance	Description	Data	Compliance	Description	Data
N/A	Ramp Length (in)	50.0	Yes	Ramp Slope (%)	8.1
Yes	Ramp Width (in)	48.0	No	Ramp XSlope (%)	8.9
N/A	Flare Type LT	N/A	N/A	Flare Type RT	N/A
N/A	Flare Slope LT (%)	N/A	N/A	Flare Slope RT (%)	N/A
N/A	Flare Traversable LT?	N/A	N/A	Flare Traversable RT?	N/A
N/A	Landing Length (in)	N/A	N/A	DWS Provided?	N/A
N/A	Landing Width (in)	N/A	N/A	DWS Contrast?	N/A
N/A	Landing Slope (%)	N/A	N/A	DWS Length (in)	N/A
N/A	Landing X Slope (%)	N/A	N/A	DWS Full Width?	N/A
N/A	Landing Curb? (Y/N)	N/A	N/A	DWS Offset (in)	N/A
N/A	Shared Landing?	N/A			
N/A	Gutter Ponding?	N/A	N/A	Gutter Slope (%)	N/A
N/A	Gutter Lip Ht (in)	N/A	N/A	Gutter X Slope (%)	N/A
N/A	Painted X Walk1?	No	N/A	Painted X Walk2?	No
	X Walk 1 Direction	To E		X Walk 2 Direction	To N
N/A	X Walk 1 Width (in)	N/A	N/A	X Walk 2 Width (in)	N/A
	X Walk 1 Slope (%)	3.5		X Walk 2 Slope (%)	3.7
	X Walk 1 X Slope (%)	6.0		X Walk 2 X Slope (%)	2.7

N/A	Ramp inside XWalk1?	N/A	N/A	Ramp inside XWalk2?	N/A
	Road Slope (%)	6.5	N/A	Clear Space?	N/A
	Road X Slope (%)	4.8	N/A	Clear Space to XWalk (in)	N/A
N/A	Any Obstructions?	N/A	N/A	Storm Grate/Utility Hazard?	N/A
	Obstruction Type			Storm Grate/Utility Type	
		N/A			N/A
		Yes		Surface Condition? (G/P)	Good

**Remove & Replace Curb Ramp With Two New Directional Ramps or Equivalent.**

Total Cost: \$ 3200.00
