# Access Compliance Report

## Public Rights-of-Way

### (Curb Ramps)

Intersection ID: 3274	Main Street: MALLARD_GREEN_PL	Cross Street: SHELLY_PINES_DR	Location: S
ADA ID: 89A4A92D51EF	Ramp Type: Perp	Initial Pass/Fail: Fail	Overall Compliance: No
Severity Score: 22.5			
Codes/Mitigation Info/Possible Solution		Field Measurements/Component Compliance

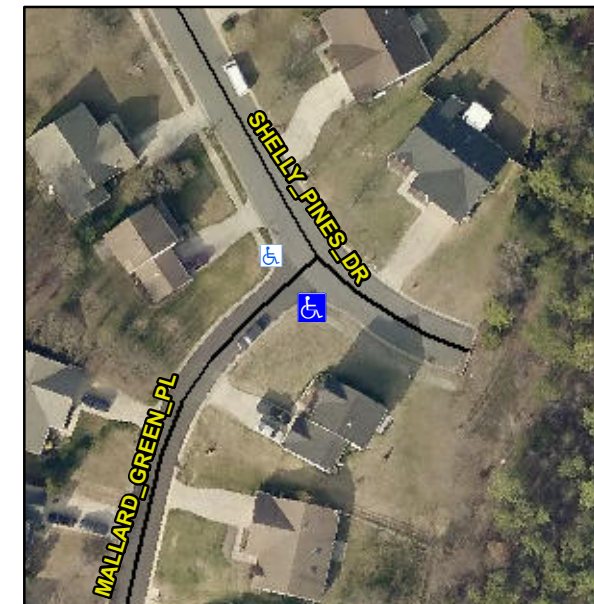
Compliance	Description	Data	Compliance	Description	Data
N/A	Ramp Length (in)	46.0	No	Ramp Slope (%)	9.4
No	Ramp Width (in)	39.0	No	Ramp XSlope (%)	3.0
N/A	Flare Type LT	N/A	N/A	Flare Type RT	N/A
N/A	Flare Slope LT (%)	N/A	N/A	Flare Slope RT (%)	N/A
N/A	Flare Traversable LT?	N/A	N/A	Flare Traversable RT?	N/A
N/A	Landing Length (in)	N/A	N/A	DWS Provided?	N/A
N/A	Landing Width (in)	N/A	N/A	DWS Contrast?	N/A
N/A	Landing Slope (%)	N/A	N/A	DWS Length (in)	N/A
N/A	Landing X Slope (%)	N/A	N/A	DWS Full Width?	N/A
N/A	Landing Curb? (Y/N)	N/A	N/A	DWS Offset (in)	N/A
N/A	Shared Landing?	N/A			
N/A	Gutter Ponding?	N/A	N/A	Gutter Slope (%)	N/A
N/A	Gutter Lip Ht (in)	N/A	N/A	Gutter X Slope (%)	N/A
N/A	Painted X Walk1?	No	N/A	Painted X Walk2?	N/A
	X Walk 1 Direction	To NW		X Walk 2 Direction	N/A
N/A	X Walk 1 Width (in)	N/A	N/A	X Walk 2 Width (in)	N/A
	X Walk 1 Slope (%)	2.5		X Walk 2 Slope (%)	N/A
	X Walk 1 X Slope (%)	3.0		X Walk 2 X Slope (%)	N/A

N/A	Ramp inside XWalk1?	N/A	N/A	Ramp inside XWalk2?	N/A
	Road Slope (%)	N/A	N/A	Clear Space?	N/A
	Road X Slope (%)	N/A	N/A	Clear Space to XWalk (in)	N/A
N/A	Any Obstructions?	N/A	N/A	Storm Grate/Utility Hazard?	N/A
	Obstruction Type			Storm Grate/Utility Type	
		N/A			N/A
			Yes	Surface Condition? (G/P)	Good

**Remove & Replace Entire Ramp.**

**R304.5.1, R304.2.2, R304.5.3**
