Access Compliance Report

Public Rights-of-Way

(Curb Ramps)

Intersection ID: 23740	Main Street: PARK_RD	Cross Street: SMITHFIELD_CHURCH_RD	Location: NE
ADA ID: 89A707AACC86	Ramp Type: PerpDiag	Initial Pass/Fail: Fail	Overall Compliance: No
		Severity Score: 37.5

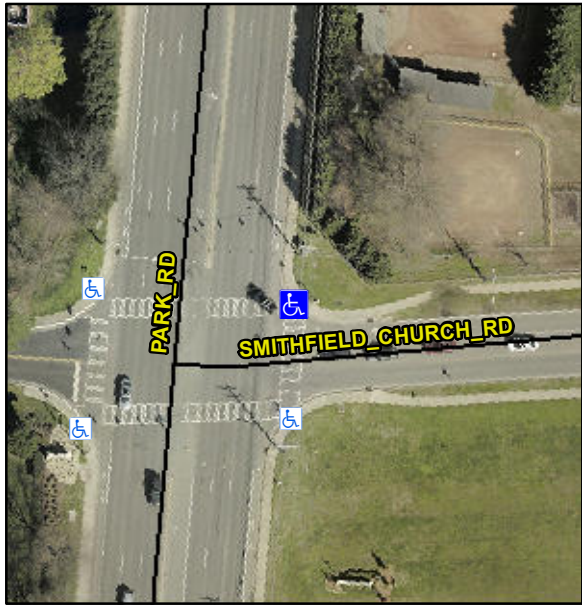
Possible Solutions:		Compliance	Description	Data	Compliance	Description	Data
	Remove & Replace Curb Ramp With Two New Directional Ramps or Equivalent.		N/A	Ramp Length (in)	62.0	No	Ramp Slope (%)	13.9
			Yes	Ramp Width (in)	48.0	No	Ramp XSlope (%)	5.7
			N/A	Flare Type LT	N/A	N/A	Flare Type RT	N/A
			N/A	Flare Slope LT (%)	N/A	N/A	Flare Slope RT (%)	N/A
			N/A	Flare Traversable LT?	N/A	N/A	Flare Traversable RT?	N/A
			N/A	Landing Length (in)	N/A	N/A	DWS Provided?	N/A
			N/A	Landing Width (in)	N/A	N/A	DWS Contrast?	N/A
			N/A	Landing Slope (%)	N/A	N/A	DWS Length (in)	N/A
			N/A	Landing X Slope (%)	N/A	N/A	DWS Full Width?	N/A
<p>Surveyor Notes:</p> <p>N/A</p> <p>PROW/ADA:</p> <p>Not Found, R304.2.2, R304.5.3</p>			N/A	Landing Curb? (Y/N)	N/A	N/A	DWS Offset (in)	N/A
			N/A	Shared Landing?	N/A			
			N/A	Gutter Ponding?	N/A	N/A	Gutter Slope (%)	N/A

N/A	Gutter Lip Ht (in)	N/A	N/A	Gutter X Slope (%)	N/A
			N/A	Painted X Walk1?	Yes	N/A	Painted X Walk2?	Yes
				X Walk 1 Direction	To NW		X Walk 2 Direction	To SW
			N/A	X Walk 1 Width (in)	103.0	N/A	X Walk 2 Width (in)	114.0
				X Walk 1 Slope (%)	9.6		X Walk 2 Slope (%)	0.8
				X Walk 1 X Slope (%)	1.1		X Walk 2 X Slope (%)	9.4
			N/A	Ramp inside XWalk1?	Yes	N/A	Ramp inside XWalk2?	Yes
			Road Slope (%)	6.3	N/A	Clear Space?	N/A	
			Road X Slope (%)	7.6	N/A	Clear Space to XWalk (in)	N/A	
		N/A	Any Obstructions?	N/A	N/A	Storm Grate/Utility Hazard?	N/A	
			Obstruction Type			Storm Grate/Utility Type		
					N/A		N/A	
						Yes	Surface Condition? (G/P)	Good
Total Cost:		\$	3200.00
