Access Compliance Report

Public Rights-of-Way

(Curb Ramps)

Intersection ID: N/A	Main Street: PINEVILLE-MATTHEWS_RD	Cross Street: N/A	Location: N
ADA ID: 89A8B66A8BD3	Ramp Type: PerpDiag	Initial Pass/Fail: Fail	Overall Compliance: No
			Severity Score: 13.75

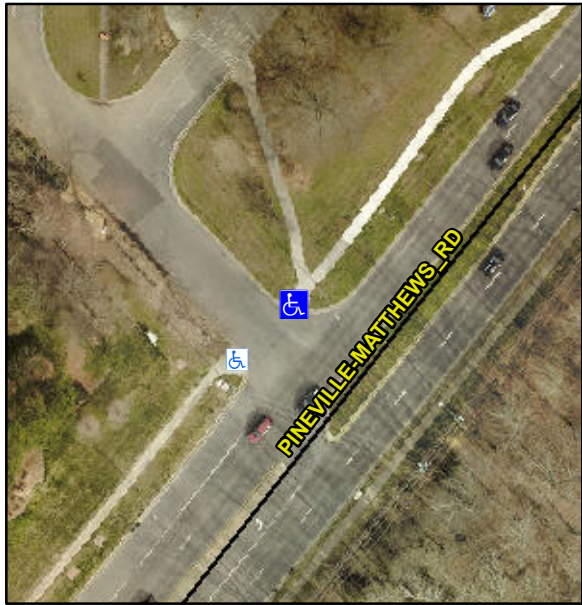
Possible Solutions:		Compliance	Description	Data	Compliance	Description	Data
	Remove & Replace Curb Ramp With Two New Directional Ramps or Equivalent.		N/A	Ramp Length (in)	154.0	No	Ramp Slope (%)	10.7
			Yes	Ramp Width (in)	48.0	No	Ramp XSlope (%)	2.9
			N/A	Flare Type LT	N/A	N/A	Flare Type RT	N/A
			N/A	Flare Slope LT (%)	N/A	N/A	Flare Slope RT (%)	N/A
			N/A	Flare Traversable LT?	N/A	N/A	Flare Traversable RT?	N/A
			N/A	Landing Length (in)	N/A	N/A	DWS Provided?	N/A
			N/A	Landing Width (in)	N/A	N/A	DWS Contrast?	N/A
			N/A	Landing Slope (%)	N/A	N/A	DWS Length (in)	N/A
			N/A	Landing X Slope (%)	N/A	N/A	DWS Full Width?	N/A
Surveyor Notes:	N/A		N/A	Landing Curb? (Y/N)	N/A	N/A	DWS Offset (in)	N/A
			N/A	Shared Landing?	N/A			
	PROW/ADA:		N/A	Gutter Ponding?	N/A	N/A	Gutter Slope (%)	N/A
	Not Found, R304.2.2, R304.5.3		N/A	Gutter Lip Ht (in)	N/A	N/A	Gutter X Slope (%)	N/A

N/A	Painted X Walk1?	No	N/A	Painted X Walk2?	No
				X Walk 1 Direction	To SW		X Walk 2 Direction	To SE
			N/A	X Walk 1 Width (in)	N/A	N/A	X Walk 2 Width (in)	N/A
				X Walk 1 Slope (%)	0.7		X Walk 2 Slope (%)	3.9
				X Walk 1 X Slope (%)	3.2		X Walk 2 X Slope (%)	0.4
			N/A	Ramp inside XWalk1?	N/A	N/A	Ramp inside XWalk2?	N/A
			Road Slope (%)	3.6	N/A	Clear Space?	N/A	
			Road X Slope (%)	1.0	N/A	Clear Space to XWalk (in)	N/A	
		N/A	Any Obstructions?	N/A	N/A	Storm Grate/Utility Hazard?	N/A	
			Obstruction Type			Storm Grate/Utility Type		
				N/A			N/A	
					Yes	Surface Condition? (G/P)	Good
