# Access Compliance Report

## Public Rights-of-Way

### (Curb Ramps)

Intersection ID: 21312	Main Street: E_ARROWOOD_RD	Cross Street: SOUTH_BV	Location: SW
ADA ID: 89B432434AC8	Ramp Type: Perp	Initial Pass/Fail: Fail	Overall Compliance: No
		Severity Score: 12.5

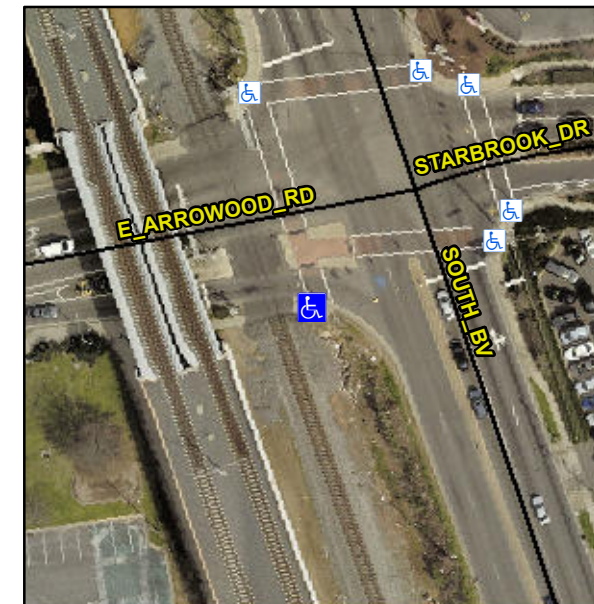
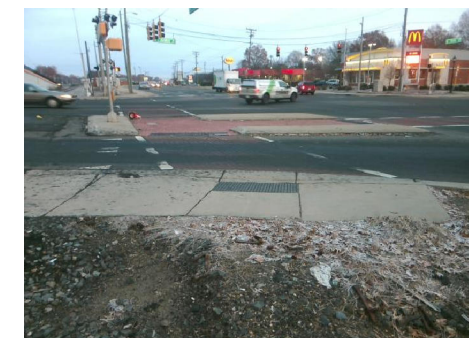
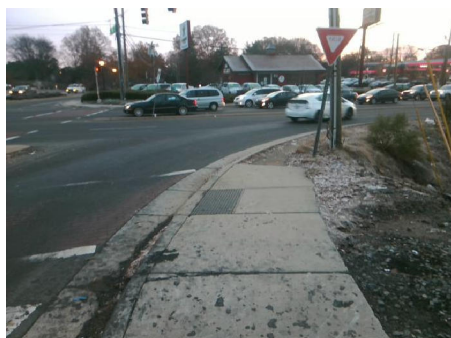
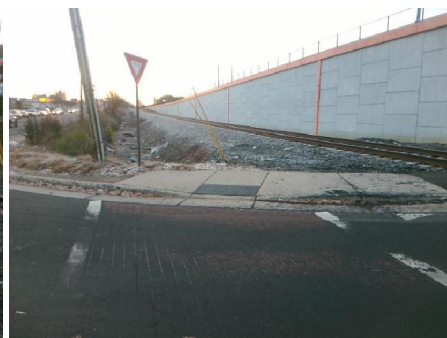
Compliance	Description	Data	Compliance	Description	Data
N/A	Ramp Length (in)	71.0	No	Ramp Slope (%)	8.7
Yes	Ramp Width (in)	48.0	Yes	Ramp XSlope (%)	1.5
N/A	Flare Type LT	N/A	N/A	Flare Type RT	N/A
N/A	Flare Slope LT (%)	N/A	N/A	Flare Slope RT (%)	N/A
N/A	Flare Traversable LT?	N/A	N/A	Flare Traversable RT?	N/A
N/A	Landing Length (in)	N/A	N/A	DWS Provided?	N/A
N/A	Landing Width (in)	N/A	N/A	DWS Contrast?	N/A
N/A	Landing Slope (%)	N/A	N/A	DWS Length (in)	N/A
N/A	Landing X Slope (%)	N/A	N/A	DWS Full Width?	N/A
N/A	Landing Curb? (Y/N)	N/A	N/A	DWS Offset (in)	N/A
N/A	Shared Landing?	N/A			
N/A	Gutter Ponding?	N/A	N/A	Gutter Slope (%)	N/A
N/A	Gutter Lip Ht (in)	N/A	N/A	Gutter X Slope (%)	N/A
N/A	Painted X Walk1?	Yes	N/A	Painted X Walk2?	N/A
	X Walk 1 Direction	To N		X Walk 2 Direction	N/A
N/A	X Walk 1 Width (in)	126.0	N/A	X Walk 2 Width (in)	N/A
	X Walk 1 Slope (%)	2.5		X Walk 2 Slope (%)	N/A
	X Walk 1 X Slope (%)	3.6		X Walk 2 X Slope (%)	N/A

N/A	Ramp inside XWalk1?	Yes	N/A	Ramp inside XWalk2?	N/A
	Road Slope (%)	N/A	N/A	Clear Space?	N/A
	Road X Slope (%)	N/A	N/A	Clear Space to XWalk (in)	N/A
N/A	Any Obstructions?	N/A	N/A	Storm Grate/Utility Hazard?	N/A
	Obstruction Type			Storm Grate/Utility Type	
		N/A			N/A
			Yes	Surface Condition? (G/P)	Good

**Remove & Replace Entire Ramp.**

**R304.2.2**

**\$ 1850.00**
