Access Compliance Report

Public Rights-of-Way

(Curb Ramps)

Intersection ID: 49556	Main Street: TEXTILE_WY	Cross Street: NODA_BV	Location: NW
ADA ID: 89B9242E24E8	Ramp Type: Perp	Initial Pass/Fail: Fail	Overall Compliance: No
Severity Score: 12.5			
Codes/Mitigation Info/Possible Solution		Field Measurements/Component Compliance

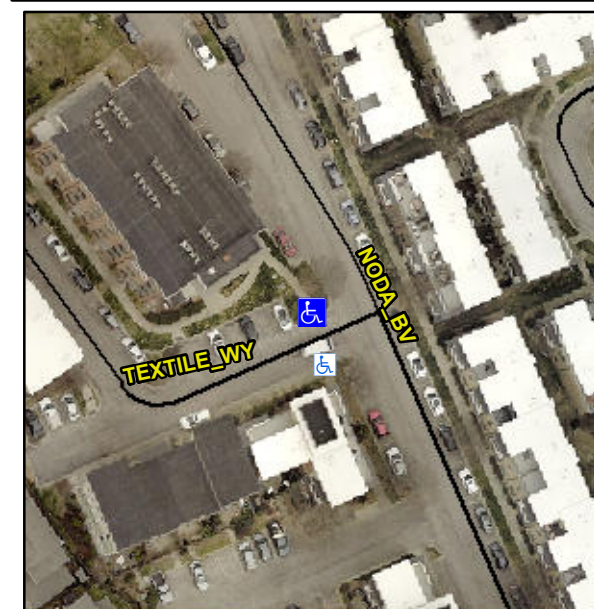
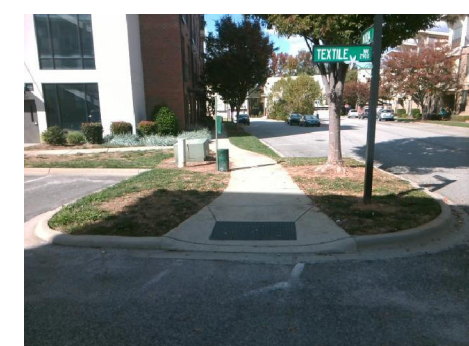
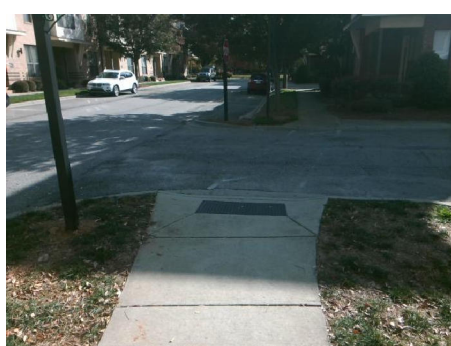
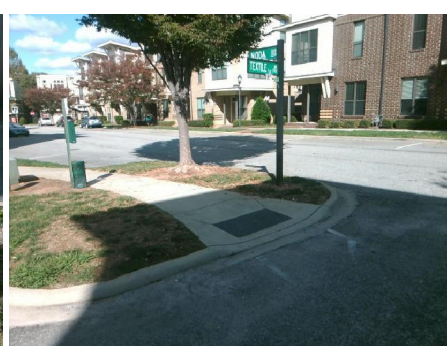
Not Found, R304.2.2

Compliance	Description	Data	Compliance	Description	Data
N/A	Ramp Length (in)	61.5	No	Ramp Slope (%)	8.5
Yes	Ramp Width (in)	48.0	Yes	Ramp XSlope (%)	1.9
N/A	Flare Type LT	N/A	N/A	Flare Type RT	N/A
N/A	Flare Slope LT (%)	N/A	N/A	Flare Slope RT (%)	N/A
N/A	Flare Traversable LT?	N/A	N/A	Flare Traversable RT?	N/A
N/A	Landing Length (in)	N/A	N/A	DWS Provided?	N/A
N/A	Landing Width (in)	N/A	N/A	DWS Contrast?	N/A
N/A	Landing Slope (%)	N/A	N/A	DWS Length (in)	N/A
N/A	Landing X Slope (%)	N/A	N/A	DWS Full Width?	N/A
N/A	Landing Curb? (Y/N)	N/A	N/A	DWS Offset (in)	N/A
N/A	Shared Landing?	N/A			
N/A	Gutter Ponding?	N/A	N/A	Gutter Slope (%)	N/A
N/A	Gutter Lip Ht (in)	N/A	N/A	Gutter X Slope (%)	N/A
N/A	Painted X Walk1?	No	N/A	Painted X Walk2?	N/A
	X Walk 1 Direction	To S		X Walk 2 Direction	N/A
N/A	X Walk 1 Width (in)	N/A	N/A	X Walk 2 Width (in)	N/A
	X Walk 1 Slope (%)	1.0		X Walk 2 Slope (%)	N/A
	X Walk 1 X Slope (%)	1.5		X Walk 2 X Slope (%)	N/A

N/A	Ramp inside XWalk1?	N/A	N/A	Ramp inside XWalk2?	N/A
	Road Slope (%)	N/A	N/A	Clear Space?	N/A
	Road X Slope (%)	N/A	N/A	Clear Space to XWalk (in)	N/A
N/A	Any Obstructions?	N/A	N/A	Storm Grate/Utility Hazard?	N/A
	Obstruction Type			Storm Grate/Utility Type	
		N/A			N/A
		Yes		Surface Condition? (G/P)	Good

Remove & Replace Entire Ramp.

Total Cost: \$ 1850.00
