# Access Compliance Report

## Public Rights-of-Way

### (Curb Ramps)

Intersection ID: 11349	Main Street: N_DAVIDSON_ST	Cross Street: PARKWOOD_AV	Location: S
ADA ID: 89C723CE28ED	Ramp Type: Perp	Initial Pass/Fail: Fail	Overall Compliance: No
Codes/Mitigation Info/Possible Solution		Field Measurements/Component Compliance

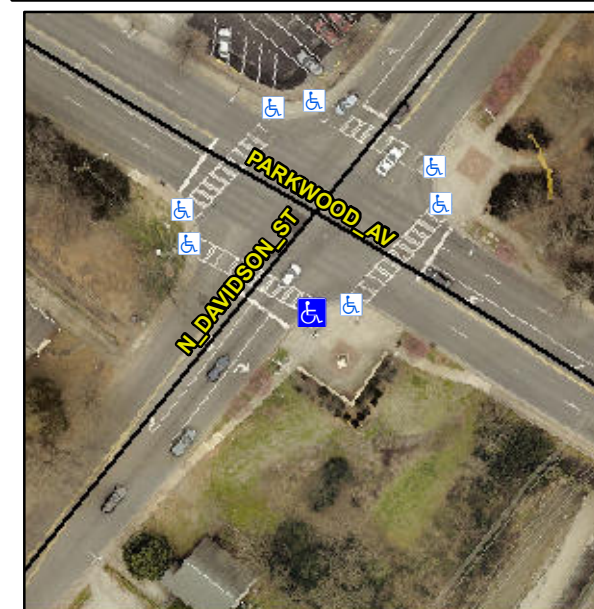
**Not Found, R304.5.1, R304.2.2**

Compliance	Description	Data	Compliance	Description	Data
N/A	Ramp Length (in)	66.5	No	Ramp Slope (%)	9.5
No	Ramp Width (in)	46.0	Yes	Ramp XSlope (%)	0.3
N/A	Flare Type LT	N/A	N/A	Flare Type RT	N/A
N/A	Flare Slope LT (%)	N/A	N/A	Flare Slope RT (%)	N/A
N/A	Flare Traversable LT?	N/A	N/A	Flare Traversable RT?	N/A
N/A	Landing Length (in)	N/A	N/A	DWS Provided?	N/A
N/A	Landing Width (in)	N/A	N/A	DWS Contrast?	N/A
N/A	Landing Slope (%)	N/A	N/A	DWS Length (in)	N/A
N/A	Landing X Slope (%)	N/A	N/A	DWS Full Width?	N/A
N/A	Landing Curb? (Y/N)	N/A	N/A	DWS Offset (in)	N/A
N/A	Shared Landing?	N/A			
N/A	Gutter Ponding?	N/A	N/A	Gutter Slope (%)	N/A
N/A	Gutter Lip Ht (in)	N/A	N/A	Gutter X Slope (%)	N/A
N/A	Painted X Walk1?	Yes	N/A	Painted X Walk2?	N/A
	X Walk 1 Direction	To NW		X Walk 2 Direction	N/A
N/A	X Walk 1 Width (in)	99.5	N/A	X Walk 2 Width (in)	N/A
	X Walk 1 Slope (%)	3.2		X Walk 2 Slope (%)	N/A
	X Walk 1 X Slope (%)	1.0		X Walk 2 X Slope (%)	N/A

N/A	Ramp inside XWalk1?	Yes	N/A	Ramp inside XWalk2?	N/A
	Road Slope (%)	N/A	N/A	Clear Space?	N/A
	Road X Slope (%)	N/A	N/A	Clear Space to XWalk (in)	N/A
N/A	Any Obstructions?	N/A	N/A	Storm Grate/Utility Hazard?	N/A
	Obstruction Type			Storm Grate/Utility Type	
		N/A			N/A
			Yes	Surface Condition? (G/P)	Good

**Remove & Replace Entire Ramp.**
