# Access Compliance Report

## Public Rights-of-Way

### (Curb Ramps)

Intersection ID: 10745	Main Street: E_35TH_ST	Cross Street: HOLT_ST	Location:	N
ADA ID: 89CEDE699840	Ramp Type: PerpDiag	Initial Pass/Fail: Fail	Overall Compliance: No	Severity Score: 13.75
Codes/Mitigation Info/Possible Solution		Field Measurements/Component Compliance

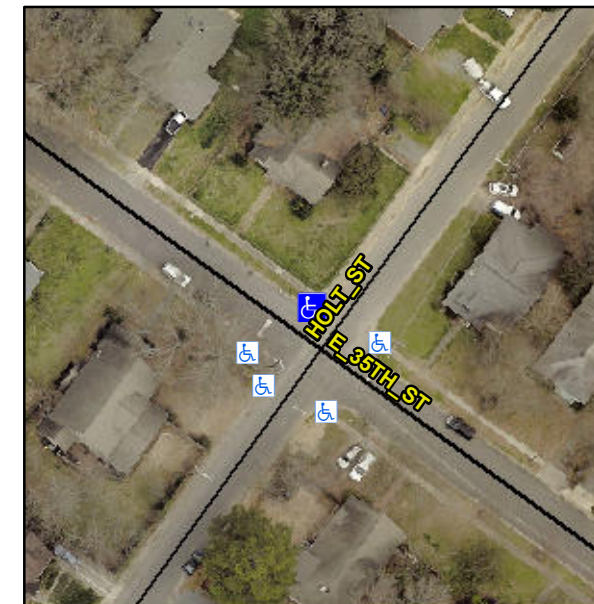
Compliance	Description	Data	Compliance	Description	Data
N/A	Ramp Length (in)	49.0	No	Ramp Slope (%)	10.8
Yes	Ramp Width (in)	48.0	No	Ramp XSlope (%)	2.5
N/A	Flare Type LT	N/A	N/A	Flare Type RT	N/A
N/A	Flare Slope LT (%)	N/A	N/A	Flare Slope RT (%)	N/A
N/A	Flare Traversable LT?	N/A	N/A	Flare Traversable RT?	N/A
N/A	Landing Length (in)	N/A	N/A	DWS Provided?	N/A
N/A	Landing Width (in)	N/A	N/A	DWS Contrast?	N/A
N/A	Landing Slope (%)	N/A	N/A	DWS Length (in)	N/A
N/A	Landing X Slope (%)	N/A	N/A	DWS Full Width?	N/A
N/A	Landing Curb? (Y/N)	N/A	N/A	DWS Offset (in)	N/A
N/A	Shared Landing?	N/A			
N/A	Gutter Ponding?	N/A	N/A	Gutter Slope (%)	N/A
N/A	Gutter Lip Ht (in)	N/A	N/A	Gutter X Slope (%)	N/A
N/A	Painted X Walk1?	No	N/A	Painted X Walk2?	No
	X Walk 1 Direction	To SW		X Walk 2 Direction	To SE
N/A	X Walk 1 Width (in)	N/A	N/A	X Walk 2 Width (in)	N/A
	X Walk 1 Slope (%)	2.9		X Walk 2 Slope (%)	3.2
	X Walk 1 X Slope (%)	3.0		X Walk 2 X Slope (%)	0.5

N/A	Ramp inside XWalk1?	N/A	N/A	Ramp inside XWalk2?	N/A
	Road Slope (%)	1.8	N/A	Clear Space?	N/A
	Road X Slope (%)	5.2	N/A	Clear Space to XWalk (in)	N/A
N/A	Any Obstructions?	N/A	N/A	Storm Grate/Utility Hazard?	N/A
	Obstruction Type			Storm Grate/Utility Type	
		N/A			N/A
			Yes	Surface Condition? (G/P)	Good

Possible Solutions:

**Remove & Replace Curb Ramp With Two New Directional Ramps or Equivalent.**

**Not Found, R304.2.2, R304.5.3**
