Access Compliance Report

Public Rights-of-Way

(Curb Ramps)

Intersection ID: 8059	Main Street: BILMARK_AV	Cross Street: CINDERELLA_RD	Location: NE
ADA ID: 89D98460200B	Ramp Type: Perp	Initial Pass/Fail: Fail	Overall Compliance: No
Codes/Mitigation Info/Possible Solution			Severity Score: 10
			Field Measurements/Component Compliance

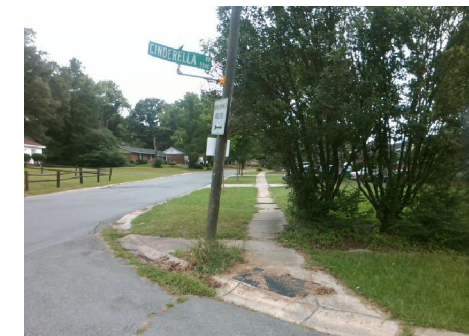
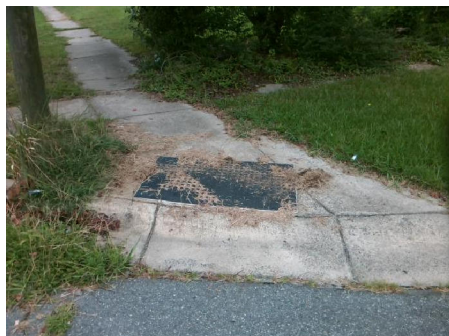
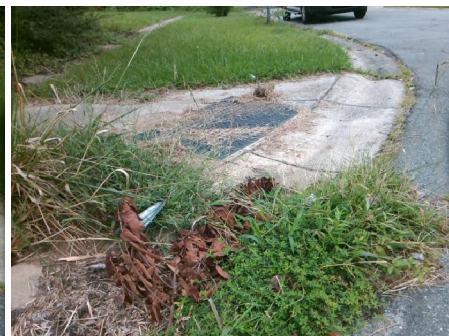
Not Found, R304.5.1, R304.5.3

Compliance	Description	Data	Compliance	Description	Data
N/A	Ramp Length (in)	38.0	Yes	Ramp Slope (%)	6.5
No	Ramp Width (in)	44.0	No	Ramp XSlope (%)	4.8
N/A	Flare Type LT	N/A	N/A	Flare Type RT	N/A
N/A	Flare Slope LT (%)	N/A	N/A	Flare Slope RT (%)	N/A
N/A	Flare Traversable LT?	N/A	N/A	Flare Traversable RT?	N/A
N/A	Landing Length (in)	N/A	N/A	DWS Provided?	N/A
N/A	Landing Width (in)	N/A	N/A	DWS Contrast?	N/A
N/A	Landing Slope (%)	N/A	N/A	DWS Length (in)	N/A
N/A	Landing X Slope (%)	N/A	N/A	DWS Full Width?	N/A
N/A	Landing Curb? (Y/N)	N/A	N/A	DWS Offset (in)	N/A
N/A	Shared Landing?	N/A			
N/A	Gutter Ponding?	N/A	N/A	Gutter Slope (%)	N/A
N/A	Gutter Lip Ht (in)	1.0	N/A	Gutter X Slope (%)	N/A
N/A	Painted X Walk1?	No	N/A	Painted X Walk2?	N/A
	X Walk 1 Direction	To S		X Walk 2 Direction	N/A
N/A	X Walk 1 Width (in)	N/A	N/A	X Walk 2 Width (in)	N/A
	X Walk 1 Slope (%)	2.9		X Walk 2 Slope (%)	N/A
	X Walk 1 X Slope (%)	3.4		X Walk 2 X Slope (%)	N/A

Remove & Replace Entire Ramp.
