Access Compliance Report

Public Rights-of-Way

(Curb Ramps)

Intersection ID: 31893	Main Street: CHAPECLANE_RD	Cross Street: GREEN_MOUNTAIN_RD	Location: NE
ADA ID: 89E38B238C1C	Ramp Type: PerpDiag	Initial Pass/Fail: Fail	Overall Compliance: No
Severity Score: 25			
Codes/Mitigation Info/Possible Solution		Field Measurements/Component Compliance

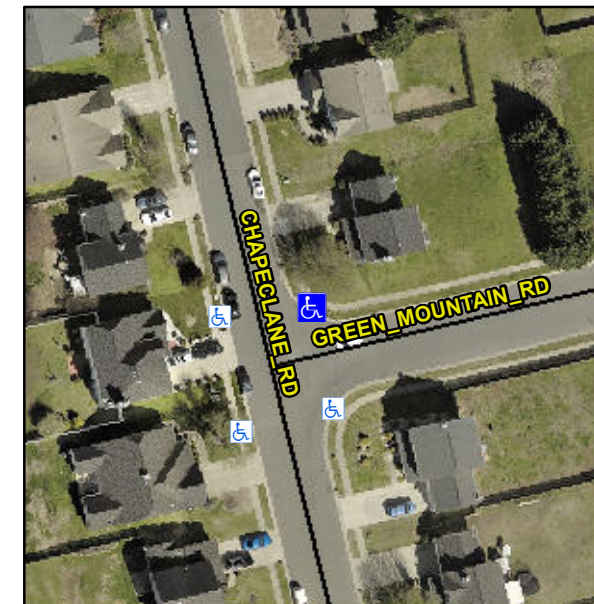
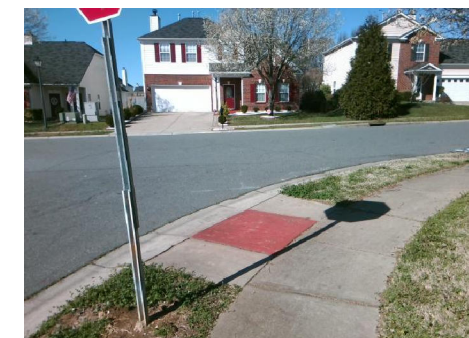
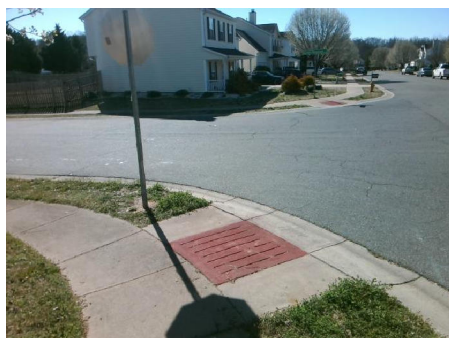
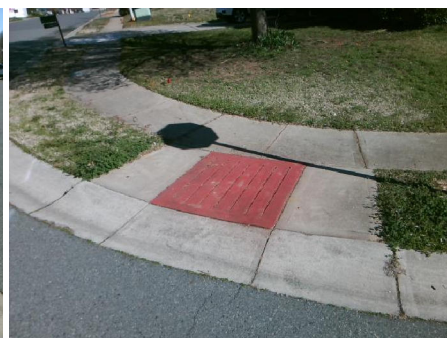
Not Found, R304.5.3

Compliance	Description	Data	Compliance	Description	Data
N/A	Ramp Length (in)	95.0	Yes	Ramp Slope (%)	5.2
Yes	Ramp Width (in)	48.0	No	Ramp XSlope (%)	8.0
N/A	Flare Type LT	N/A	N/A	Flare Type RT	N/A
N/A	Flare Slope LT (%)	N/A	N/A	Flare Slope RT (%)	N/A
N/A	Flare Traversable LT?	N/A	N/A	Flare Traversable RT?	N/A
N/A	Landing Length (in)	N/A	N/A	DWS Provided?	N/A
N/A	Landing Width (in)	N/A	N/A	DWS Contrast?	N/A
N/A	Landing Slope (%)	N/A	N/A	DWS Length (in)	N/A
N/A	Landing X Slope (%)	N/A	N/A	DWS Full Width?	N/A
N/A	Landing Curb? (Y/N)	N/A	N/A	DWS Offset (in)	N/A
N/A	Shared Landing?	N/A			
N/A	Gutter Ponding?	N/A	N/A	Gutter Slope (%)	N/A
N/A	Gutter Lip Ht (in)	N/A	N/A	Gutter X Slope (%)	N/A
N/A	Painted X Walk1?	No	N/A	Painted X Walk2?	No
	X Walk 1 Direction	To W		X Walk 2 Direction	To S
N/A	X Walk 1 Width (in)	N/A	N/A	X Walk 2 Width (in)	N/A
	X Walk 1 Slope (%)	6.2		X Walk 2 Slope (%)	0.4
	X Walk 1 X Slope (%)	1.6		X Walk 2 X Slope (%)	4.6

N/A	Ramp inside XWalk1?	N/A	N/A	Ramp inside XWalk2?	N/A
	Road Slope (%)	3.6	N/A	Clear Space?	N/A
	Road X Slope (%)	1.3	N/A	Clear Space to XWalk (in)	N/A
N/A	Any Obstructions?	N/A	N/A	Storm Grate/Utility Hazard?	N/A
	Obstruction Type			Storm Grate/Utility Type	
		N/A			N/A
			Yes	Surface Condition? (G/P)	Good

Remove & Replace Curb Ramp With Two New Directional Ramps or Equivalent.
