# Access Compliance Report

## Public Rights-of-Way

### (Curb Ramps)

| Intersection ID: 10034564 | Main Street: PINEY GROVE RD | Cross Street: N/A | Location: NE |

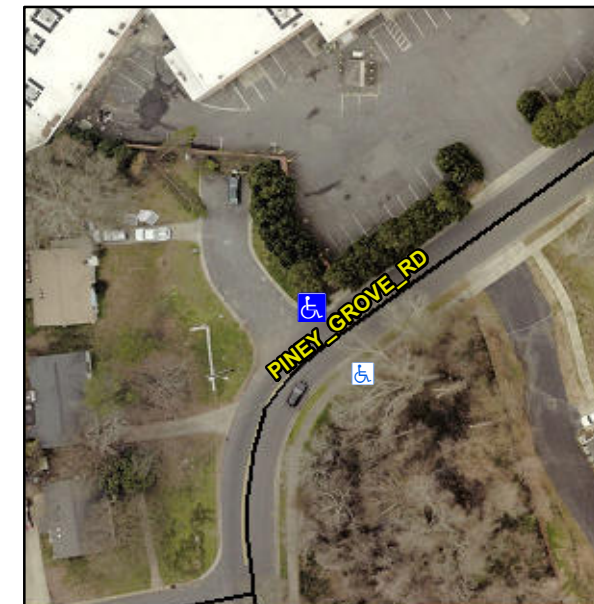
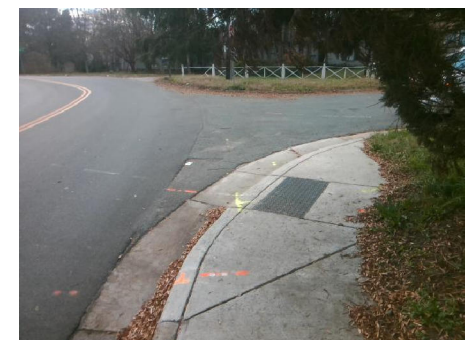
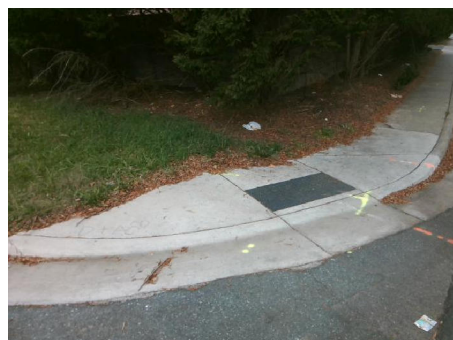
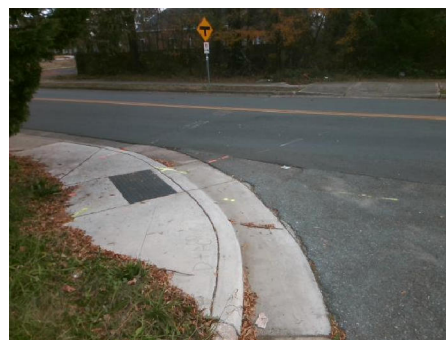
| ADA ID: 89EA362564AE | Ramp Type: BlendTrans1 | Initial Pass/Fail: Pass | Overall Compliance: No |
| Severity Score: 0.25 | | | |

**R304.5.3, R304.2.1, R305.2**

| Compliance | Description | Data | Compliance | Description | Data |
|---|---|---|---|---|---|
| Yes | Ramp Width (in) | 48.0 | No | BlendTrans XSlope (%) | 2.2 |
| No | Landing Length (in) | 33.0 | Yes | DWS Provided? | Yes |
| No | Landing X Slope (%) | 3.1 | Yes | DWS Full Width? | Yes |
| N/A | Landing Curb? (Y/N) | No | No | DWS Offset (in) | 4.0 |
| Yes | Gutter Lip Ht (in) | 0.0 | No | Gutter X Slope (%) | 2.9 |

**Remove & Replace Curb Ramp With Two New Directional Ramps or Equivalent. Remove & Replace Gutter.**

Total Cost: \$ 3950.00
