# Access Compliance Report

## Public Rights-of-Way

### (Curb Ramps)

| Intersection ID: N/A | Main Street: SANDY_PORTER_RD | Cross Street: N/A | Location: SE |

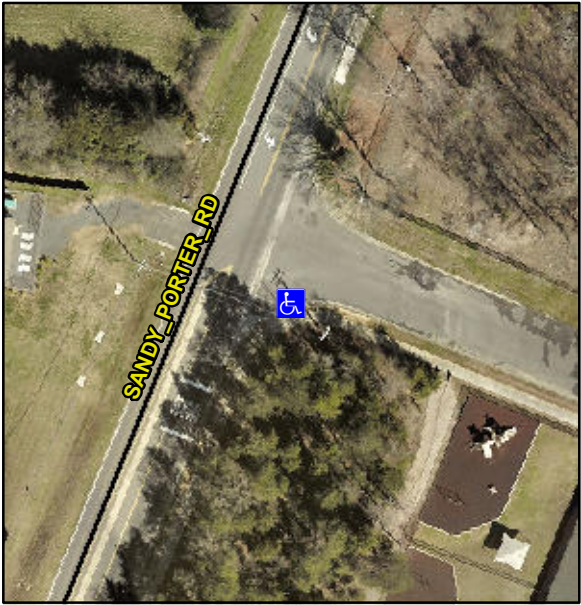
| | | Yes | Ramp Width (in) | 52.0 | No | Ramp XSlope (%) | 3.2 |
| <p>Surveyor Notes:</p> <p>N/A</p> <p>PROW/ADA:</p> <p><b>Not Found, R304.5.3, R304.2.1, R304.2.2-Perp, R304.3.2-Para, R305.1.4, R305.2, R302.7.2</b></p> | | No | Landing X Slope (%) | N/A | No | DWS Full Width? | No |
| | | No | Gutter Lip Ht (in) | 1.5 | No | Gutter X Slope (%) | 2.2 |

| | <b>Remove &amp; Replace Curb Ramp With Two New Directional Ramps or Equivalent. Remove &amp; Replace Gutter.</b> | <b>Compliance</b> | <b>Description</b> | <b>Data</b> | <b>Compliance</b> | <b>Description</b> | <b>Data</b> |
