Access Compliance Report

Public Rights-of-Way

(Curb Ramps)

Intersection ID: 11610	Main Street: COLE_DR	Cross Street: GLENVILLE_AV	Location: NW
ADA ID: 8A0AD22C38D0	Ramp Type: ParaDiag	Initial Pass/Fail: Fail	Overall Compliance: No
		Severity Score: 12.5

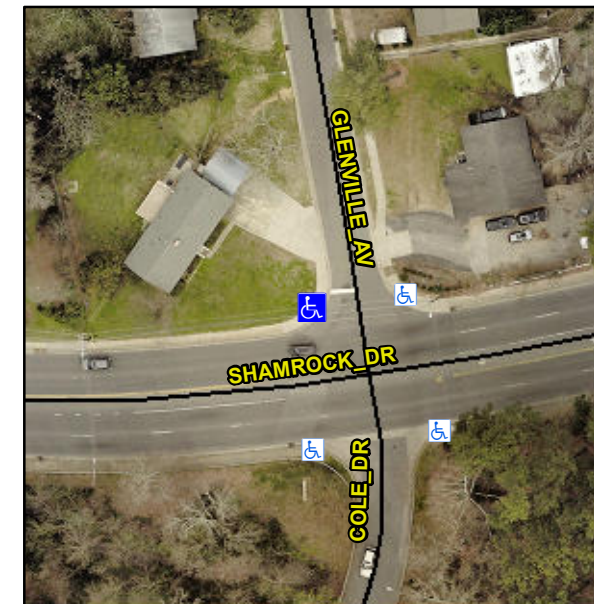
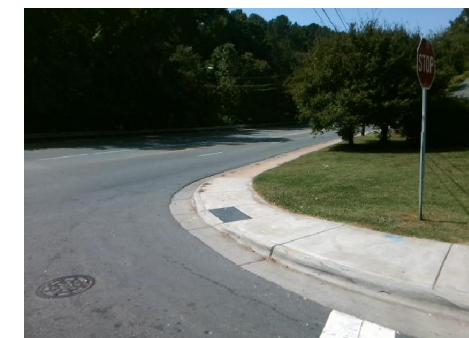
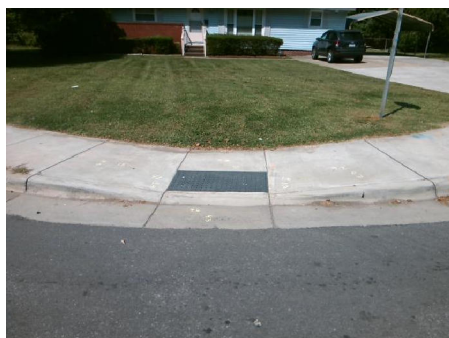
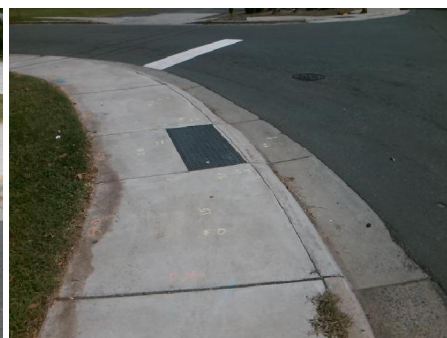
Surveyor Notes:

LT RP < 5%

Compliance	Description	Data	Compliance	Description	Data
N/A	Ramp Length LT (in)	54.0	N/A	Ramp Length RT (in)	61.0
Yes	Ramp Width LT (in)	59.0	Yes	Ramp Width RT (in)	60.0
Yes	Ramp Slope LT (%)	1.5	No	Ramp Slope RT (%)	9.2
Yes	Ramp XSlope LT (%)	0.3	Yes	Ramp XSlope RT (%)	0.7
N/A	Landing Length (in)	N/A	N/A	DWS Provided?	N/A
N/A	Landing Width (in)	N/A	N/A	DWS Contrast?	N/A
N/A	Landing Slope (%)	N/A	N/A	DWS Length (in)	N/A
N/A	Landing X Slope (%)	N/A	N/A	DWS Full Width?	N/A
N/A	Landing Curb? (Y/N)	N/A	N/A	DWS Offset (in)	N/A
N/A	Shared Landing?	N/A			
N/A	Gutter Ponding?	N/A	N/A	Gutter Slope (%)	N/A
N/A	Gutter Lip Ht (in)	N/A	N/A	Gutter X Slope (%)	N/A
N/A	Painted X Walk1?	No	N/A	Painted X Walk2?	No
	X Walk 1 Direction	To S		X Walk 2 Direction	To E
N/A	X Walk 1 Width (in)	N/A	N/A	X Walk 2 Width (in)	N/A
	X Walk 1 Slope (%)	3.4		X Walk 2 Slope (%)	5.0
	X Walk 1 X Slope (%)	4.3		X Walk 2 X Slope (%)	1.6
N/A	Ramp inside XWalk1?	N/A	N/A	Ramp inside XWalk2?	N/A

Road Slope (%)	4.6	N/A	Clear Space?	N/A
	Road X Slope (%)	4.3	N/A	Clear Space to XWalk (in)	N/A
N/A	Any Obstructions?	N/A	N/A	Storm Grate/Utility Hazard?	N/A
	Obstruction Type			Storm Grate/Utility Type	
		N/A			N/A
			Yes	Surface Condition? (G/P)	Good
			N/A	Curb Slope (%)	21.4

Possible Solutions:

Remove & Replace Curb Ramp With Two New Directional Ramps or Equivalent.

R304.3.2
