Access Compliance Report

Public Rights-of-Way

(Curb Ramps)

Intersection ID: N/A	Main Street: PROVIDENCE RD W	Cross Street: N/A	Location: NE
ADA ID: 8A0C9A3C837C	Ramp Type: Para	Initial Pass/Fail: Pass	Overall Compliance: No
		Severity Score: 2.75

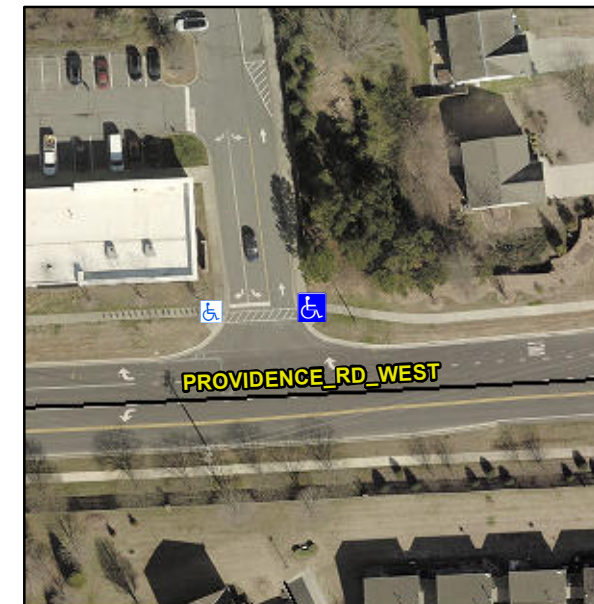
Compliance	Description	Data	Compliance	Description	Data
N/A	Ramp Length LT (in)	40.0	N/A	Ramp Length RT (in)	58.0
Yes	Ramp Width LT (in)	60.0	Yes	Ramp Width RT (in)	60.0
Yes	Ramp Slope LT (%)	7.6	Yes	Ramp Slope RT (%)	6.6
No	Ramp XSlope LT (%)	2.4	No	Ramp XSlope RT (%)	2.6
Yes	Landing Length (in)	62.0	Yes	DWS Provided?	Yes
Yes	Landing Width (in)	60.0	Yes	DWS Contrast?	Yes
No	Landing Slope (%)	2.9	Yes	DWS Length (in)	24.0
No	Landing X Slope (%)	3.7	No	DWS Full Width?	No
N/A	Landing Curb? (Y/N)	No	No	DWS Offset (in)	3.0
N/A	Shared Landing?	No			
Yes	Gutter Ponding?	No	Yes	Gutter Slope (%)	1.1
Yes	Gutter Lip Ht (in)	0.0	No	Gutter X Slope (%)	3.4
N/A	Painted X Walk1?	Yes	N/A	Painted X Walk2?	N/A
	X Walk 1 Direction	To W		X Walk 2 Direction	N/A
N/A	X Walk 1 Width (in)	60.0	N/A	X Walk 2 Width (in)	N/A
	X Walk 1 Slope (%)	2.1		X Walk 2 Slope (%)	N/A
	X Walk 1 X Slope (%)	3.1		X Walk 2 X Slope (%)	N/A
Yes	Ramp inside XWalk1?	Yes	N/A	Ramp inside XWalk2?	N/A

Road Slope (%)	N/A	N/A	Clear Space?	Yes
	Road X Slope (%)	N/A	N/A	Clear Space to XWalk (in)	N/A
Yes	Any Obstructions?	No	Yes	Storm Grate/Utility Hazard?	No
	Obstruction Type			Storm Grate/Utility Type	
		N/A			N/A
			Yes	Surface Condition? (G/P)	Good
			N/A	Curb Slope (%)	6.2

Possible Solutions:

**Remove & Replace Entire Ramp.
Remove & Replace Gutter.**
