Access Compliance Report

Public Rights-of-Way

(Curb Ramps)

Intersection ID: 12779	Main Street: E_TRADE_ST	Cross Street: S_DAVIDSON_ST	Location:	N
ADA ID: 8A13E520B4DE	Ramp Type: Perp	Initial Pass/Fail: Pass	Overall Compliance: No	Severity Score: 0.25
Codes/Mitigation Info/Possible Solution		Field Measurements/Component Compliance

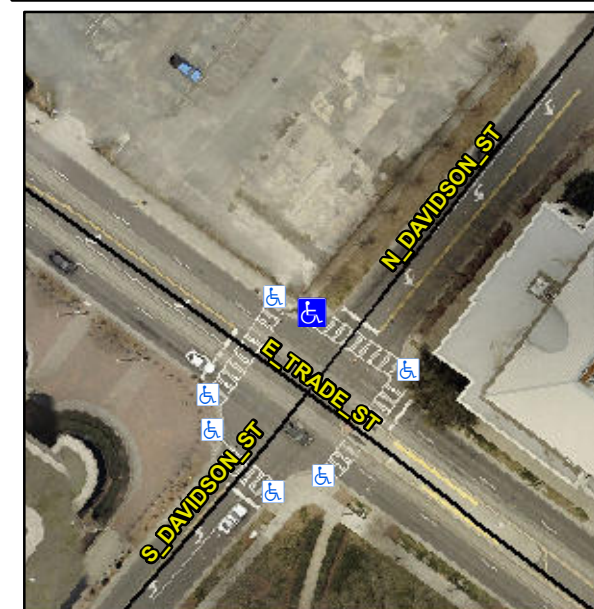
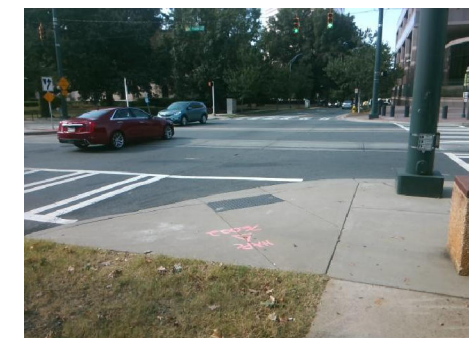
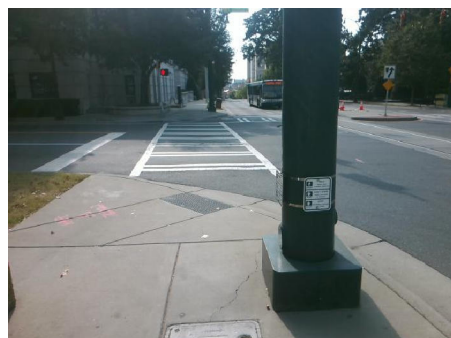
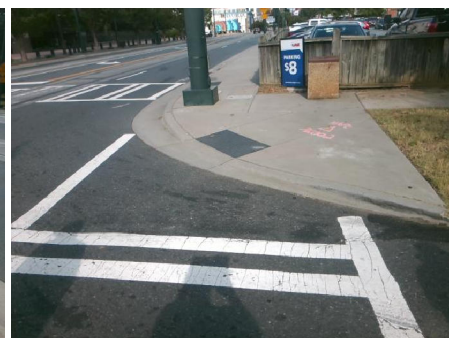
Compliance	Description	Data	Compliance	Description	Data
N/A	Ramp Length (in)	24.0	Yes	Ramp Slope (%)	5.7
Yes	Ramp Width (in)	48.0	Yes	Ramp XSlope (%)	3.0
N/A	Flare Type LT	Sloped	N/A	Flare Type RT	N/A
N/A	Flare Slope LT (%)	6.9	N/A	Flare Slope RT (%)	1.9
N/A	Flare Traversable LT?	Yes	N/A	Flare Traversable RT?	No
Yes	Landing Length (in)	59.0	Yes	DWS Provided?	Yes
Yes	Landing Width (in)	48.0	Yes	DWS Contrast?	Yes
No	Landing Slope (%)	2.4	Yes	DWS Length (in)	24.0
Yes	Landing X Slope (%)	3.5	Yes	DWS Full Width?	Yes
N/A	Landing Curb? (Y/N)	No	Yes	DWS Offset (in)	0.0
N/A	Shared Landing?	No			
Yes	Gutter Ponding?	No	Yes	Gutter Slope (%)	1.3
Yes	Gutter Lip Ht (in)	0.0	Yes	Gutter X Slope (%)	1.8
N/A	Painted X Walk1?	Yes	N/A	Painted X Walk2?	N/A
	X Walk 1 Direction	To SE		X Walk 2 Direction	N/A
N/A	X Walk 1 Width (in)	114.0	N/A	X Walk 2 Width (in)	N/A
	X Walk 1 Slope (%)	0.5		X Walk 2 Slope (%)	N/A
	X Walk 1 X Slope (%)	3.8		X Walk 2 X Slope (%)	N/A

Yes	Ramp inside XWalk1?	Yes	N/A	Ramp inside XWalk2?	N/A
	Road Slope (%)	N/A	N/A	Clear Space?	Yes
	Road X Slope (%)	N/A	N/A	Clear Space to XWalk (in)	N/A
Yes	Any Obstructions?	No	Yes	Storm Grate/Utility Hazard?	No
	Obstruction Type			Storm Grate/Utility Type	
		N/A			N/A
			Yes	Surface Condition? (G/P)	Good

Possible Solutions:

Remove & Replace Entire Ramp.
