Access Compliance Report

Public Rights-of-Way

(Curb Ramps)

Intersection ID: 16139	Main Street: BILTMORE_DR	Cross Street: CHEROKEE_RD	Location: NE
ADA ID: 8A19411156EE	Ramp Type: Perp	Initial Pass/Fail: Fail	Overall Compliance: No
Severity Score: 33.75			
Codes/Mitigation Info/Possible Solution		Field Measurements/Component Compliance

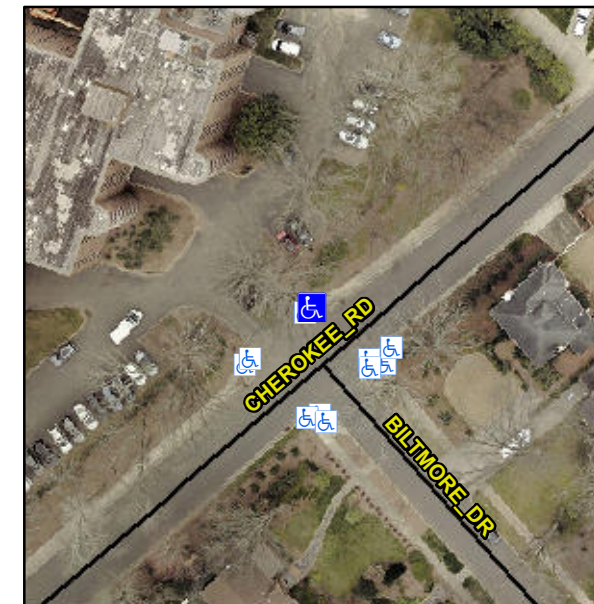
R304.5.1, R304.2.2

Compliance	Description	Data	Compliance	Description	Data
N/A	Ramp Length (in)	31.0	No	Ramp Slope (%)	13.1
No	Ramp Width (in)	47.0	Yes	Ramp XSlope (%)	0.2
N/A	Flare Type LT	N/A	N/A	Flare Type RT	N/A
N/A	Flare Slope LT (%)	N/A	N/A	Flare Slope RT (%)	N/A
N/A	Flare Traversable LT?	N/A	N/A	Flare Traversable RT?	N/A
N/A	Landing Length (in)	N/A	N/A	DWS Provided?	N/A
N/A	Landing Width (in)	N/A	N/A	DWS Contrast?	N/A
N/A	Landing Slope (%)	N/A	N/A	DWS Length (in)	N/A
N/A	Landing X Slope (%)	N/A	N/A	DWS Full Width?	N/A
N/A	Landing Curb? (Y/N)	N/A	N/A	DWS Offset (in)	N/A
N/A	Shared Landing?	N/A			
N/A	Gutter Ponding?	N/A	N/A	Gutter Slope (%)	N/A
N/A	Gutter Lip Ht (in)	N/A	N/A	Gutter X Slope (%)	N/A
N/A	Painted X Walk1?	No	N/A	Painted X Walk2?	N/A
	X Walk 1 Direction	To SE		X Walk 2 Direction	N/A
N/A	X Walk 1 Width (in)	N/A	N/A	X Walk 2 Width (in)	N/A
	X Walk 1 Slope (%)	2.1		X Walk 2 Slope (%)	N/A
	X Walk 1 X Slope (%)	1.2		X Walk 2 X Slope (%)	N/A

N/A	Ramp inside XWalk1?	N/A	N/A	Ramp inside XWalk2?	N/A
	Road Slope (%)	N/A	N/A	Clear Space?	N/A
	Road X Slope (%)	N/A	N/A	Clear Space to XWalk (in)	N/A
N/A	Any Obstructions?	N/A	N/A	Storm Grate/Utility Hazard?	N/A
	Obstruction Type			Storm Grate/Utility Type	
		N/A			N/A
		Yes		Surface Condition? (G/P)	Good

Possible Solutions:

Remove & Replace Entire Ramp.
