# Access Compliance Report

## Public Rights-of-Way

### (Curb Ramps)

Intersection ID: 47646	Main Street: ALDWYCH_WY	Cross Street: DESHLER_MORRIS_LN	Location: SE
ADA ID: 8A2BBB78F3D9	Ramp Type: Perp	Initial Pass/Fail: Fail	Overall Compliance: No
			Severity Score: 21.25

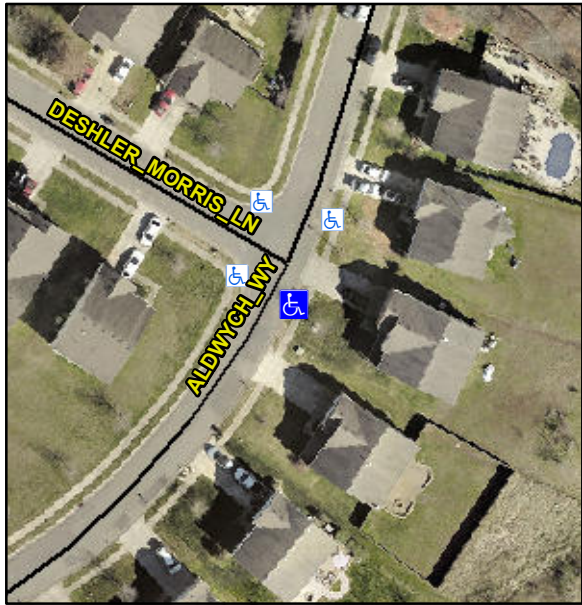
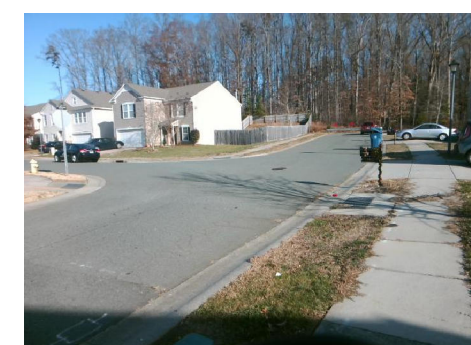
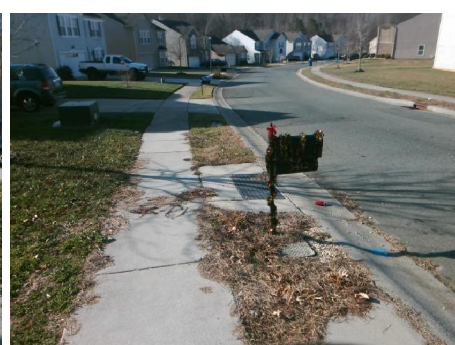
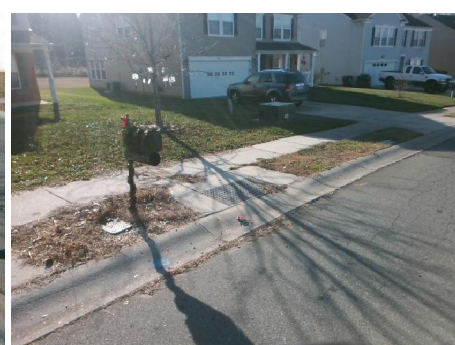
Possible Solutions:		Compliance	Description	Data	Compliance	Description	Data
	Remove & Replace Entire Ramp.		N/A	Ramp Length (in)	47.0	Yes	Ramp Slope (%)	7.1
			No	Ramp Width (in)	47.5	No	Ramp XSlope (%)	5.7
			N/A	Flare Type LT	N/A	N/A	Flare Type RT	N/A
			N/A	Flare Slope LT (%)	N/A	N/A	Flare Slope RT (%)	N/A
			N/A	Flare Traversable LT?	N/A	N/A	Flare Traversable RT?	N/A
			N/A	Landing Length (in)	N/A	N/A	DWS Provided?	N/A
			N/A	Landing Width (in)	N/A	N/A	DWS Contrast?	N/A
			N/A	Landing Slope (%)	N/A	N/A	DWS Length (in)	N/A
			N/A	Landing X Slope (%)	N/A	N/A	DWS Full Width?	N/A
Surveyor Notes:		N/A	N/A	Landing Curb? (Y/N)	N/A	N/A	DWS Offset (in)	N/A
PROW/ADA:		Not Found, R304.5.1, R304.5.3	N/A	Shared Landing?	N/A	N/A	Gutter Ponding?	N/A
			N/A	Gutter Lip Ht (in)	N/A	N/A	Gutter Slope (%)	N/A
			N/A	Painted X Walk1?	No	N/A	Gutter X Slope (%)	N/A

X Walk 1 Direction	To NW	N/A	Painted X Walk2?	N/A
			N/A	X Walk 1 Width (in)	N/A	N/A	X Walk 2 Direction	N/A
				X Walk 1 Slope (%)	2.7		X Walk 2 Width (in)	N/A
				X Walk 1 X Slope (%)	6.7		X Walk 2 Slope (%)	N/A
			N/A	Ramp inside XWalk1?	N/A	N/A	X Walk 2 X Slope (%)	N/A
				Road Slope (%)	N/A	N/A	Ramp inside XWalk2?	N/A
				Road X Slope (%)	N/A	N/A	Clear Space?	N/A
			N/A	Any Obstructions?	N/A	N/A	Clear Space to XWalk (in)	N/A
				Obstruction Type		N/A	Storm Grate/Utility Hazard?	N/A
						N/A	Storm Grate/Utility Type	
						Yes	Surface Condition? (G/P)	Good
Total Cost:		\$ 1850.00						
Street 1 Name		ALDWYCH WY						
Stop Condition-Street 2		None						
Street 2 Name		N/A						
Stop Condition-Street 1		N/A
