Access Compliance Report Public Rights-of-Way (Curb Ramps)

Intersection ID: 49556 Main Street: TEXTILE_WY Cross Street: NODA_BV Location: SW

ADA ID: 8A2C88A2BF5A Ramp Type: BlendTrans2 Initial Pass/Fail: Pass Overall Compliance: No Severity Score: 17.5

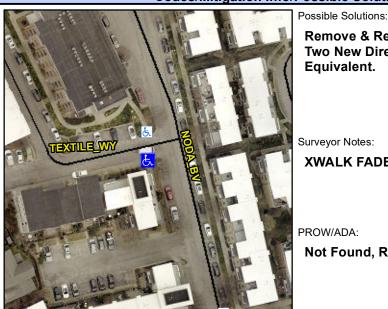
XWALK FADED, CURB WIDTH 47.0

Not Found, R304.2.3, R305, R302.7.2

Remove & Replace Curb Ramp With Two New Directional Ramps or Equivalent.
