# Access Compliance Report

## Public Rights-of-Way

### (Curb Ramps)

Intersection ID: 48458	Main Street: QUINN_DR	Cross Street: FOX_POINT_DR	Location: NW
ADA ID: 8A3151DBDE1A	Ramp Type: PerpDiag	Initial Pass/Fail: Fail	Overall Compliance: No
Severity Score: 33.75			
Codes/Mitigation Info/Possible Solution		Field Measurements/Component Compliance

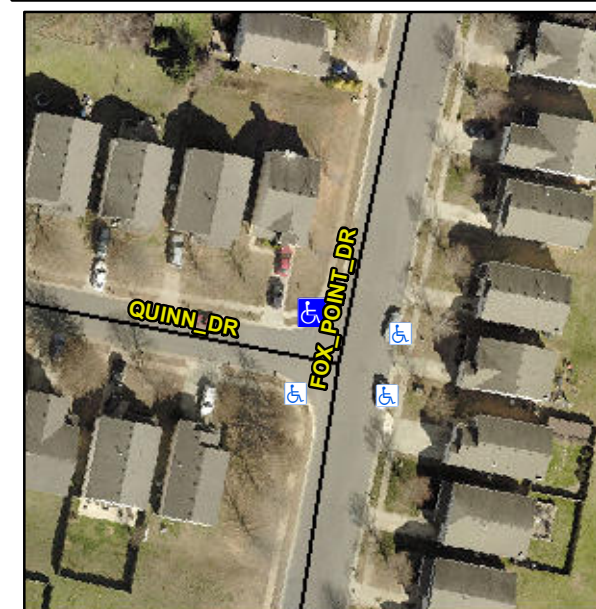
**Not Found, R304.5.1, R304.2.2, R304.5.3**

Compliance	Description	Data	Compliance	Description	Data
N/A	Ramp Length (in)	47.0	No	Ramp Slope (%)	11.6
No	Ramp Width (in)	43.0	No	Ramp XSlope (%)	6.6
N/A	Flare Type LT	N/A	N/A	Flare Type RT	N/A
N/A	Flare Slope LT (%)	N/A	N/A	Flare Slope RT (%)	N/A
N/A	Flare Traversable LT?	N/A	N/A	Flare Traversable RT?	N/A
N/A	Landing Length (in)	N/A	N/A	DWS Provided?	N/A
N/A	Landing Width (in)	N/A	N/A	DWS Contrast?	N/A
N/A	Landing Slope (%)	N/A	N/A	DWS Length (in)	N/A
N/A	Landing X Slope (%)	N/A	N/A	DWS Full Width?	N/A
N/A	Landing Curb? (Y/N)	N/A	N/A	DWS Offset (in)	N/A
N/A	Shared Landing?	N/A			
N/A	Gutter Ponding?	N/A	N/A	Gutter Slope (%)	N/A
N/A	Gutter Lip Ht (in)	N/A	N/A	Gutter X Slope (%)	N/A
N/A	Painted X Walk1?	No	N/A	Painted X Walk2?	No
	X Walk 1 Direction	To S		X Walk 2 Direction	To SE
N/A	X Walk 1 Width (in)	N/A	N/A	X Walk 2 Width (in)	N/A
	X Walk 1 Slope (%)	5.5		X Walk 2 Slope (%)	5.9
	X Walk 1 X Slope (%)	7.0		X Walk 2 X Slope (%)	4.3

N/A	Ramp inside XWalk1?	N/A	N/A	Ramp inside XWalk2?	N/A
	Road Slope (%)	6.7	N/A	Clear Space?	N/A
	Road X Slope (%)	0.9	N/A	Clear Space to XWalk (in)	N/A
N/A	Any Obstructions?	N/A	N/A	Storm Grate/Utility Hazard?	N/A
	Obstruction Type			Storm Grate/Utility Type	
		N/A			N/A
			Yes	Surface Condition? (G/P)	Good

**Remove & Replace Curb Ramp With Two New Directional Ramps or Equivalent.**
