Access Compliance Report

Public Rights-of-Way

(Curb Ramps)

Intersection ID: 17457	Main Street: S_WENDOVER_RD	Cross Street: VERNON_DR	Location: W
ADA ID: 8A35864B82A5	Ramp Type: Perp	Initial Pass/Fail: Fail	Overall Compliance: No
		Severity Score: 37.5

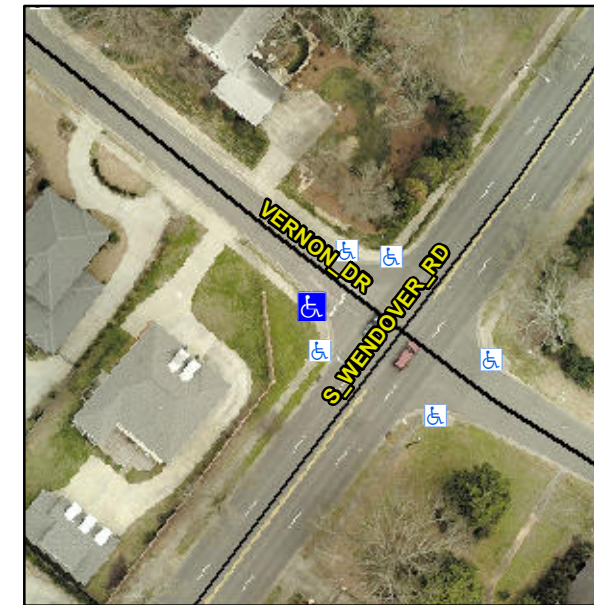
R304.2.2, R304.5.3

Compliance	Description	Data	Compliance	Description	Data
N/A	Ramp Length (in)	87.0	No	Ramp Slope (%)	10.1
Yes	Ramp Width (in)	48.0	No	Ramp XSlope (%)	7.6
N/A	Flare Type LT	N/A	N/A	Flare Type RT	N/A
N/A	Flare Slope LT (%)	N/A	N/A	Flare Slope RT (%)	N/A
N/A	Flare Traversable LT?	N/A	N/A	Flare Traversable RT?	N/A
N/A	Landing Length (in)	N/A	N/A	DWS Provided?	N/A
N/A	Landing Width (in)	N/A	N/A	DWS Contrast?	N/A
N/A	Landing Slope (%)	N/A	N/A	DWS Length (in)	N/A
N/A	Landing X Slope (%)	N/A	N/A	DWS Full Width?	N/A
N/A	Landing Curb? (Y/N)	N/A	N/A	DWS Offset (in)	N/A
N/A	Shared Landing?	N/A			
N/A	Gutter Ponding?	N/A	N/A	Gutter Slope (%)	N/A
N/A	Gutter Lip Ht (in)	N/A	N/A	Gutter X Slope (%)	N/A
N/A	Painted X Walk1?	No	N/A	Painted X Walk2?	N/A
	X Walk 1 Direction	To NE		X Walk 2 Direction	N/A
N/A	X Walk 1 Width (in)	N/A	N/A	X Walk 2 Width (in)	N/A
	X Walk 1 Slope (%)	1.1		X Walk 2 Slope (%)	N/A
	X Walk 1 X Slope (%)	3.9		X Walk 2 X Slope (%)	N/A

N/A	Ramp inside XWalk1?	N/A	N/A	Ramp inside XWalk2?	N/A
	Road Slope (%)	N/A	N/A	Clear Space?	N/A
	Road X Slope (%)	N/A	N/A	Clear Space to XWalk (in)	N/A
N/A	Any Obstructions?	N/A	N/A	Storm Grate/Utility Hazard?	N/A
	Obstruction Type			Storm Grate/Utility Type	
		N/A			N/A
			Yes	Surface Condition? (G/P)	Good

Remove & Replace Entire Ramp.

\$ 1850.00
