Access Compliance Report

Public Rights-of-Way

(Curb Ramps)

Intersection ID: 12267	Main Street: CENTRAL_AV	Cross Street: LOUISE_AV	Location:	N
ADA ID: 8A4A531BA50A	Ramp Type: BlendTrans1	Initial Pass/Fail: Fail	Overall Compliance: No	Severity Score: 8.75

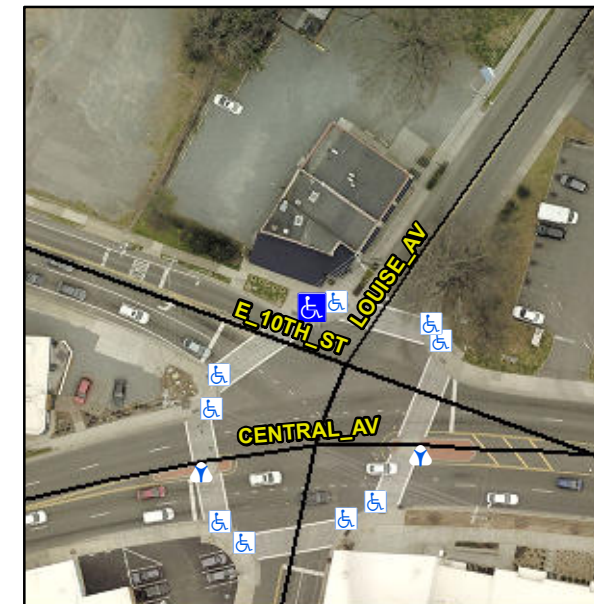
Not Found, R304.5.1

Compliance	Description	Data	Compliance	Description	Data
N/A	Ramp Length (in)	72.5	Yes	BlendTrans Slope (%)	3.3
No	Ramp Width (in)	47.5	Yes	BlendTrans XSlope (%)	1.2
N/A	Flare Type LT	N/A	N/A	Flare Type RT	N/A
N/A	Flare Slope LT (%)	N/A	N/A	Flare Slope RT (%)	N/A
N/A	Flare Traversable LT?	N/A	N/A	Flare Traversable RT?	N/A
N/A	Landing Length (in)	N/A	N/A	DWS Provided?	N/A
N/A	Landing Width (in)	N/A	N/A	DWS Contrast?	N/A
N/A	Landing Slope (%)	N/A	N/A	DWS Length (in)	N/A
N/A	Landing X Slope (%)	N/A	N/A	DWS Full Width?	N/A
N/A	Landing Curb? (Y/N)	N/A	N/A	DWS Offset (in)	N/A
N/A	Shared Landing?	N/A			
N/A	Gutter Ponding?	N/A	N/A	Gutter Slope (%)	N/A
N/A	Gutter Lip Ht (in)	N/A	N/A	Gutter X Slope (%)	N/A
N/A	Painted X Walk1?	Yes	N/A	Painted X Walk2?	N/A
	X Walk 1 Direction	To SW		X Walk 2 Direction	N/A
	X Walk 1 Width (in)	144.0		X Walk 2 Width (in)	N/A
	X Walk 1 Slope (%)	0.5		X Walk 2 Slope (%)	N/A
	X Walk 1 X Slope (%)	2.9		X Walk 2 X Slope (%)	N/A

N/A	Ramp inside XWalk1?	Yes	N/A	Ramp inside XWalk2?	N/A
	Road Slope (%)	2.9		Clear Space?	N/A
	Road X Slope (%)	0.5	N/A	Clear Space to XWalk (in)	N/A
N/A	Any Obstructions?	N/A	N/A	Storm Grate/Utility Hazard?	N/A
	Obstruction Type			Storm Grate/Utility Type	
		N/A			N/A
			Yes	Surface Condition? (G/P)	Good
			No	Curb Slope (%)	7.8

Remove & Replace Curb Ramp With Two New Directional Ramps or Equivalent.
