Access Compliance Report

Public Rights-of-Way

(Curb Ramps)

Intersection ID: 8040	Main Street: STATESVILLE_AV	Cross Street: ALMA_CT	Location: SE
ADA ID: 8A5875E57778	Ramp Type: Perp	Initial Pass/Fail: Fail	Overall Compliance: No
Codes/Mitigation Info/Possible Solution			Severity Score: 35
			Field Measurements/Component Compliance

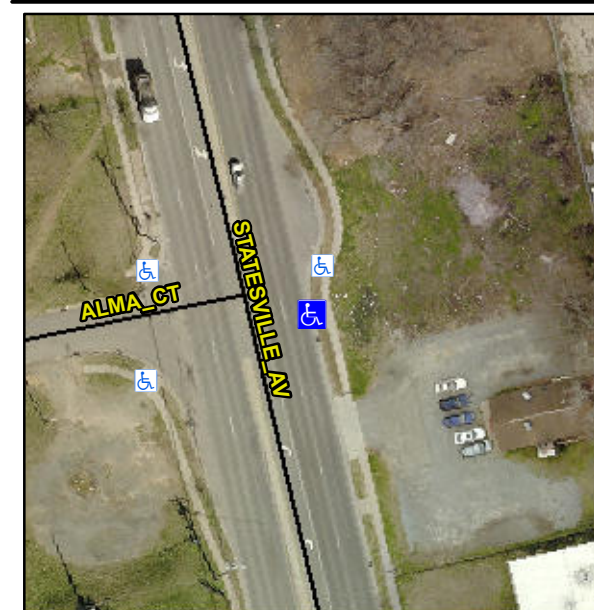
Not Found, R304.5.1, R304.2.2

Compliance	Description	Data	Compliance	Description	Data
N/A	Ramp Length (in)	59.0	No	Ramp Slope (%)	12.5
No	Ramp Width (in)	47.5	Yes	Ramp XSlope (%)	2.9
N/A	Flare Type LT	N/A	N/A	Flare Type RT	N/A
N/A	Flare Slope LT (%)	N/A	N/A	Flare Slope RT (%)	N/A
N/A	Flare Traversable LT?	N/A	N/A	Flare Traversable RT?	N/A
N/A	Landing Length (in)	N/A	N/A	DWS Provided?	N/A
N/A	Landing Width (in)	N/A	N/A	DWS Contrast?	N/A
N/A	Landing Slope (%)	N/A	N/A	DWS Length (in)	N/A
N/A	Landing X Slope (%)	N/A	N/A	DWS Full Width?	N/A
N/A	Landing Curb? (Y/N)	N/A	N/A	DWS Offset (in)	N/A
N/A	Shared Landing?	N/A			
N/A	Gutter Ponding?	N/A	N/A	Gutter Slope (%)	N/A
N/A	Gutter Lip Ht (in)	N/A	N/A	Gutter X Slope (%)	N/A
N/A	Painted X Walk1?	No	N/A	Painted X Walk2?	N/A
	X Walk 1 Direction	To SW		X Walk 2 Direction	N/A
N/A	X Walk 1 Width (in)	N/A	N/A	X Walk 2 Width (in)	N/A
	X Walk 1 Slope (%)	2.0		X Walk 2 Slope (%)	N/A
	X Walk 1 X Slope (%)	3.4		X Walk 2 X Slope (%)	N/A

N/A	Ramp inside XWalk1?	N/A	N/A	Ramp inside XWalk2?	N/A
	Road Slope (%)	N/A	N/A	Clear Space?	N/A
	Road X Slope (%)	N/A	N/A	Clear Space to XWalk (in)	N/A
N/A	Any Obstructions?	N/A	N/A	Storm Grate/Utility Hazard?	N/A
	Obstruction Type			Storm Grate/Utility Type	
		N/A			N/A
			Yes	Surface Condition? (G/P)	Good

Possible Solutions:

Remove & Replace Entire Ramp.
