# Access Compliance Report

## Public Rights-of-Way

### (Curb Ramps)

| Intersection ID: 52442 | Main Street: WOODWARD_AV | Cross Street: BENDING_BIRCH_PL | Location: NW |

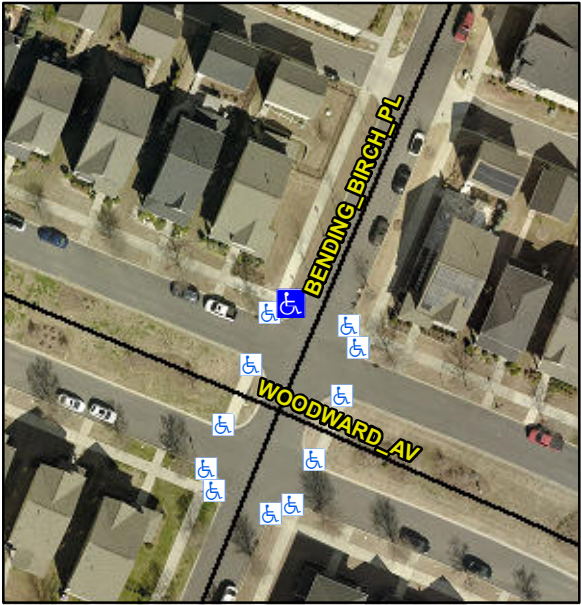
| ADA ID: 8A59A01E0C68 | Ramp Type: Directional1 | Initial Pass/Fail: Fail | Overall Compliance: No |

| Codes/Mitigation Info/Possible Solution | | | Field Measurements/Component Compliance | | | |
|---|---|---|---|---|---|---|
| | | | No | Ramp Slope (%) | 9.3 | N/A |
| | | | No | Ramp XSlope (%) | 4.1 | N/A |
| <p>PROW/ADA:</p> <p>R304.2.2, R304.5.3</p> | | | | X Walk 1 Direction | To E | N/A |

| Codes/Mitigation Info/Possible Solution | | | Field Measurements/Component Compliance | | | |
|---|---|---|---|---|---|---|
| | <b>Remove &amp; Replace Entire Ramp.</b> | | N/A | Ramp Length (in) | 76.5 | N/A |
| Total Cost: | | \$ 1600.00 | | | | |
