# Access Compliance Report

## Public Rights-of-Way

### (Curb Ramps)

Intersection ID: 9571	Main Street: PEACEFUL_WAY_DR	Cross Street: RUSH_WIND_DR	Location:	N
ADA ID: 8A7EA10C7B8E	Ramp Type: Perp	Initial Pass/Fail: Fail	Overall Compliance: No	Severity Score: 21.25

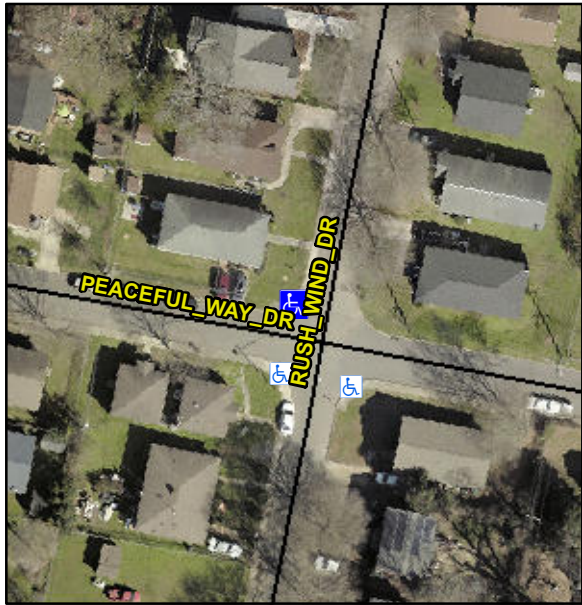
Possible Solutions:		Compliance	Description	Data	Compliance	Description	Data
	Remove & Replace Entire Ramp.		N/A	Ramp Length (in)	67.5	No	Ramp Slope (%)	8.6
			No	Ramp Width (in)	42.5	Yes	Ramp XSlope (%)	0.6
			N/A	Flare Type LT	N/A	N/A	Flare Type RT	N/A
			N/A	Flare Slope LT (%)	N/A	N/A	Flare Slope RT (%)	N/A
			N/A	Flare Traversable LT?	N/A	N/A	Flare Traversable RT?	N/A
			N/A	Landing Length (in)	N/A	N/A	DWS Provided?	N/A
			N/A	Landing Width (in)	N/A	N/A	DWS Contrast?	N/A
			N/A	Landing Slope (%)	N/A	N/A	DWS Length (in)	N/A
			N/A	Landing X Slope (%)	N/A	N/A	DWS Full Width?	N/A
Surveyor Notes:			N/A	Landing Curb? (Y/N)	N/A	N/A	DWS Offset (in)	N/A
N/A			N/A	Shared Landing?	N/A			
PROW/ADA:			N/A	Gutter Ponding?	Yes	N/A	Gutter Slope (%)	N/A
R304.5.1, R304.2.2			N/A	Gutter Lip Ht (in)	N/A	N/A	Gutter X Slope (%)	N/A

N/A	Painted X Walk1?	No	N/A	Painted X Walk2?	N/A
				X Walk 1 Direction	To S		X Walk 2 Direction	N/A
			N/A	X Walk 1 Width (in)	N/A	N/A	X Walk 2 Width (in)	N/A
				X Walk 1 Slope (%)	1.4		X Walk 2 Slope (%)	N/A
				X Walk 1 X Slope (%)	3.1		X Walk 2 X Slope (%)	N/A
			N/A	Ramp inside XWalk1?	N/A	N/A	Ramp inside XWalk2?	N/A
				Road Slope (%)	N/A	N/A	Clear Space?	N/A
				Road X Slope (%)	N/A	N/A	Clear Space to XWalk (in)	N/A
			N/A	Any Obstructions?	N/A	N/A	Storm Grate/Utility Hazard?	N/A
				Obstruction Type			Storm Grate/Utility Type	
						N/A		N/A
						Yes	Surface Condition? (G/P)	Good
		</
