Access Compliance Report

Public Rights-of-Way

(Curb Ramps)

| Intersection ID: 4411 | Main Street: CLAUDE_FREEMAN_DR | Cross Street: DAVID_TAYLOR_DR | Location: SE |

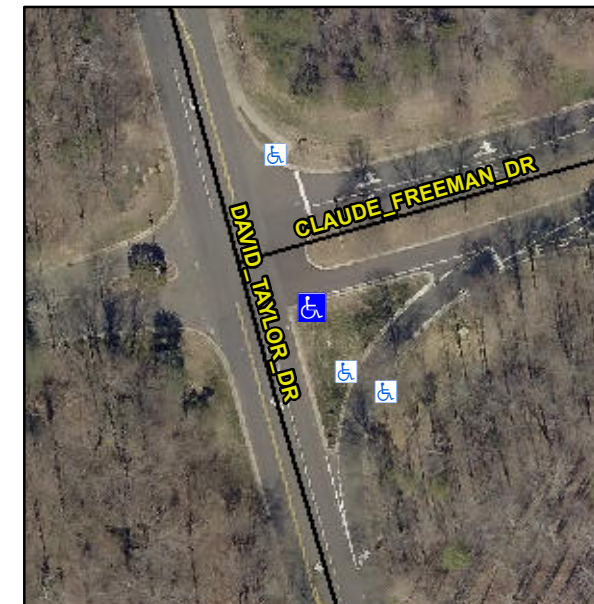
| ADA ID: 8A867DD0DFC3 | Ramp Type: MedianPerp | Initial Pass/Fail: Fail | Overall Compliance: No |
| | | Severity Score: 15 | |

| Compliance | Description | Data | Compliance | Description | Data |
|---|---|---|---|---|---|
| N/A | Ramp Length (in) | 64.0 | Yes | Ramp Slope (%) | 8.1 |
| Yes | Ramp Width (in) | 48.0 | Yes | Ramp XSlope (%) | 1.9 |
| | | No | | Surface Condition? (G/P) | Poor |

Possible Solutions:

Remove & Replace Entire Ramp.

R302.7
