# Access Compliance Report

## Public Rights-of-Way

### (Curb Ramps)

| Intersection ID: 10024219 | Main Street: COVENTRY COURT LN | Cross Street: N/A | Location: NE |

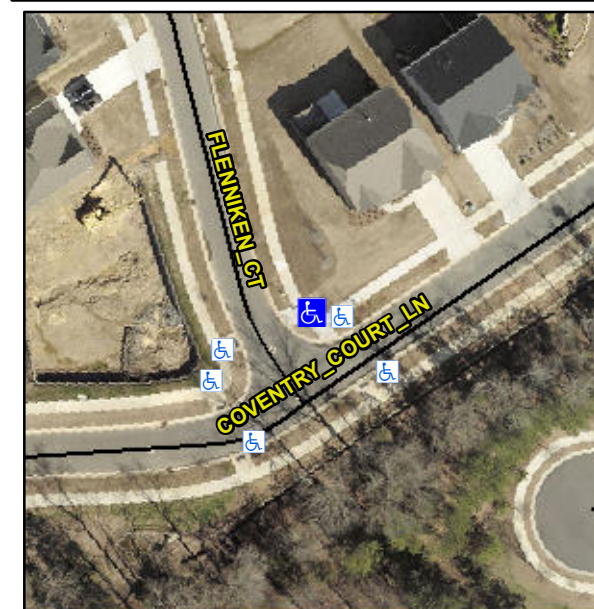
| ADA ID: 8A8912312F7E | Ramp Type: Perp | Initial Pass/Fail: Fail | Overall Compliance: No |
| Severity Score: 10 | | | |

**Not Found, R304.5.1, R304.5.3**

| Compliance | Description | Data | Compliance | Description | Data |
|---|---|---|---|---|---|
| N/A | Ramp Length (in) | 95.5 | Yes | Ramp Slope (%) | 7.9 |
| No | Ramp Width (in) | 46.5 | No | Ramp XSlope (%) | 3.5 |

**Remove & Replace Entire Ramp.**

Total Cost: \$ 1850.00
