# Access Compliance Report

## Public Rights-of-Way

### (Curb Ramps)

Intersection ID: 13538	Main Street: SOUTHWOOD_AV	Cross Street: W_PARK_AV	Location: S
ADA ID: 8AA443D5767C	Ramp Type: BlendTrans1	Initial Pass/Fail: Fail	Overall Compliance: No
Severity Score: 1.25			
Codes/Mitigation Info/Possible Solution		Field Measurements/Component Compliance

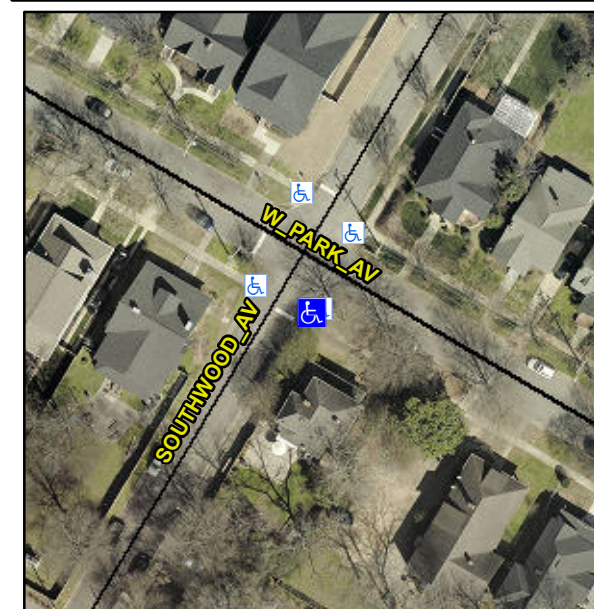
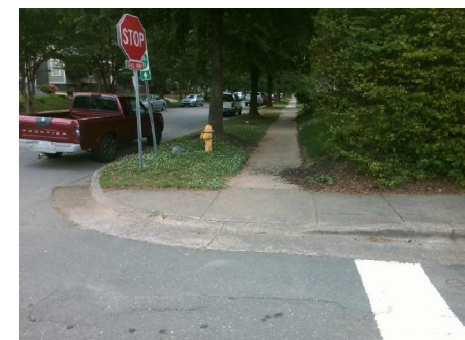
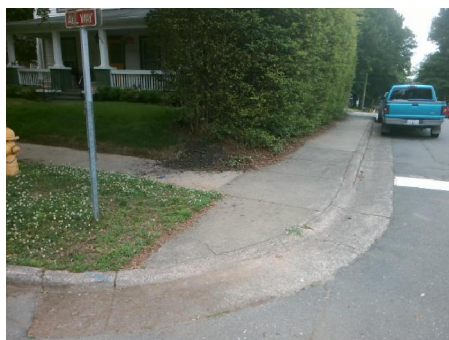
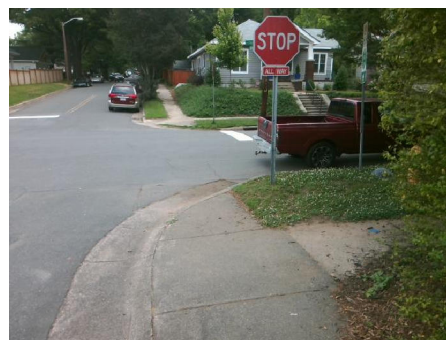
**Not Found, R304.5.3**

Compliance	Description	Data	Compliance	Description	Data
N/A	Ramp Length (in)	63.0	Yes	BlendTrans Slope (%)	0.2
Yes	Ramp Width (in)	60.0	No	BlendTrans XSlope (%)	3.2
N/A	Flare Type LT	N/A	N/A	Flare Type RT	N/A
N/A	Flare Slope LT (%)	N/A	N/A	Flare Slope RT (%)	N/A
N/A	Flare Traversable LT?	N/A	N/A	Flare Traversable RT?	N/A
N/A	Landing Length (in)	N/A	N/A	DWS Provided?	N/A
N/A	Landing Width (in)	N/A	N/A	DWS Contrast?	N/A
N/A	Landing Slope (%)	N/A	N/A	DWS Length (in)	N/A
N/A	Landing X Slope (%)	N/A	N/A	DWS Full Width?	N/A
N/A	Landing Curb? (Y/N)	N/A	N/A	DWS Offset (in)	N/A
N/A	Shared Landing?	N/A			
N/A	Gutter Ponding?	N/A	N/A	Gutter Slope (%)	N/A
N/A	Gutter Lip Ht (in)	N/A	N/A	Gutter X Slope (%)	N/A
N/A	Painted X Walk1?	No	N/A	Painted X Walk2?	N/A
	X Walk 1 Direction	To NW		X Walk 2 Direction	N/A
	X Walk 1 Width (in)	N/A		X Walk 2 Width (in)	N/A
	X Walk 1 Slope (%)	1.4		X Walk 2 Slope (%)	N/A
	X Walk 1 X Slope (%)	2.2		X Walk 2 X Slope (%)	N/A

N/A	Ramp inside XWalk1?	N/A	N/A	Ramp inside XWalk2?	N/A
	Road Slope (%)	2.2		Clear Space?	N/A
	Road X Slope (%)	1.4	N/A	Clear Space to XWalk (in)	N/A
N/A	Any Obstructions?	N/A	N/A	Storm Grate/Utility Hazard?	N/A
	Obstruction Type			Storm Grate/Utility Type	
		N/A			N/A
			Yes	Surface Condition? (G/P)	Good
			No	Curb Slope (%)	26.0

**Remove & Replace Curb Ramp With Two New Directional Ramps or Equivalent.**

Total Cost: \$ 3200.00
