## **Access Compliance Report Public Rights-of-Way** (Curb Ramps)

Intersection ID: 9741 Main Street: CADMIUM\_CT **Cross Street: CASA\_CT** Location: S **Overall Compliance: No** ADA ID: 8AB013804E67 Ramp Type: BlendTrans2 Initial Pass/Fail: Fail **Severity Score:** 10

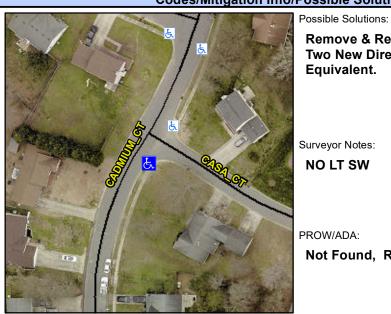
Surveyor Notes: **NO LT SW**

Not Found, R304.5.1, R304.5.3

Field Measurements/Component Compliance							
Compl	ance Description	Data	Comp	iance Description	Data		
N/A	Ramp Length (in)	53.0	Yes	BlendTrans Slope (%)	4.0		
No	Ramp Width (in)	47.0	No	BlendTrans XSlope (%)	4.2		
N/A	Flare Type LT	N/A	N/A	Flare Type RT	N/A		
N/A	Flare Slope LT (%)	N/A	N/A	Flare Slope RT (%)	N/A		
N/A	Flare Traversable LT?	N/A	N/A	Flare Traversable RT?	N/A		
N/A	Landing Length (in)	N/A	N/A	DWS Provided?	N/A		
N/A	Landing Width (in)	N/A	N/A	DWS Contrast?	N/A		
N/A	Landing Slope (%)	N/A	N/A	DWS Length (in)	N/A		
N/A	Landing X Slope (%)	N/A	N/A	DWS Full Width?	N/A		
N/A	Landing Curb? (Y/N)	N/A	N/A	DWS Offset (in)	N/A		
N/A	Shared Landing?	N/A					
N/A	Gutter Ponding?	N/A	N/A	Gutter Slope (%)	N/A		
N/A	Gutter Lip Ht (in)	N/A	N/A	Gutter X Slope (%)	N/A		
N/A	Painted X Walk1?	No	N/A	Painted X Walk2?	N/A		
	X Walk 1 Direction	To NE		X Walk 2 Direction	N/A		
	X Walk 1 Width (in)	N/A		X Walk 2 Width (in)	N/A

X Walk 1 Slope (%)	3.5		X Walk 2 Slope (%)	N/A		
	X Walk 1 X Slope (%)	2.2		X Walk 2 X Slope (%)	N/A		
N/A	Ramp inside XWalk1?	N/A	N/A	Ramp inside XWalk2?	N/A		
	Road Slope (%)	2.2		Clear Space?	N/A		
	Road X Slope (%)	3.5	N/A	Clear Space to XWalk (in)	N/A		
N/A	Any Obstructions?	N/A	N/A	Storm Grate/Utility Hazard?	N/A		
	Obstruction Type			Storm Grate/Utility Type			
		N/A			N/A		
			Yes	Surface Condition? (G/P)	Good		
			No	Curb Slope (%)	8.1

**CASA CT** Street 1 Name Stop Condition-Street 1 StopSign Street 2 Name N/A Stop Condition-Street 2 N/A Remove & Replace Curb Ramp With Two New Directional Ramps or Equivalent.
