## Access Compliance Report Public Rights-of-Way (Curb Ramps)

Intersection ID: 46732 Main Street: DARCY\_HOPKINS\_DR Cross Street: THREATT\_WOODS\_DR Location: SW

ADA ID: 8AB7DDEDDB4D Ramp Type: BlendTrans1 Initial Pass/Fail: Fail Overall Compliance: No Severity Score: 8.75

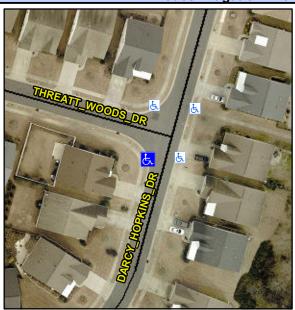
CURB GAP 1.0, CURB LIP 1.0

Not Found, R304.5.1

| Compliance Description | | Data | Comp | liance Description | Data |
|---|---|---|---|---|---|
| No | Ramp Width (in) | 40.5 | Yes | BlendTrans XSlope (%) | 0.7 |
| | | | No | Curb Slope (%) | 12.3 |

Remove & Replace Curb Ramp With Two New Directional Ramps or Equivalent.
