Access Compliance Report

Public Rights-of-Way

(Curb Ramps)

Intersection ID: 6944	Main Street: MOUNT_HOLLY_RD	Cross Street: WINDING_CANYON_DR	Location:	N
ADA ID: 8ABE32413602	Ramp Type: Combination1	Initial Pass/Fail: Fail	Overall Compliance: No	Severity Score: 26.25

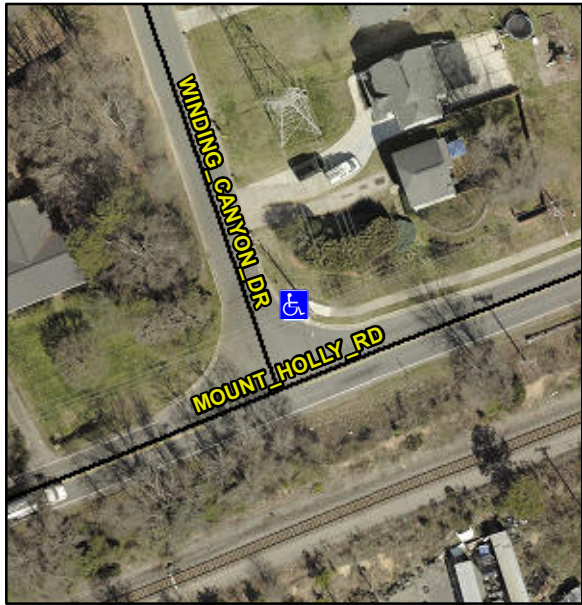
Possible Solutions:			Compliance	Description	Data	Compliance	Description	Data
	Remove & Replace Entire Ramp.			N/A	Ramp Length LT (in)	63.0	N/A	Ramp Length RT (in)	66.0
				Yes	Ramp Width LT (in)	59.0	Yes	Ramp Width RT (in)	60.0
				Yes	Ramp Slope LT (%)	0.5	No	Ramp Slope RT (%)	13.0
				No	Ramp XSlope LT (%)	2.4	No	Ramp XSlope RT (%)	3.3
				N/A	Ramp Length (in)	44.0	Yes	Ramp Slope (%)	0.6
				Yes	Ramp Width (in)	54.0	No	Ramp XSlope (%)	4.4
	Surveyor Notes:			N/A	Flare Type LT	N/A	N/A	Flare Type RT	N/A
	LT RP < 5%			N/A	Flare Slope LT (%)	N/A	N/A	Flare Slope RT (%)	N/A
				N/A	Flare Traversable LT?	N/A	N/A	Flare Traversable RT?	N/A
PROW/ADA:			N/A	Landing Length (in)	N/A	N/A	DWS Provided?	N/A	
Not Found, R304.5.3, R304.3.2			N/A	Landing Width (in)	N/A	N/A	DWS Contrast?	N/A	
			N/A	Landing Slope (%)	N/A	N/A	DWS Length (in)	N/A

N/A	Landing X Slope (%)	N/A	N/A	DWS Full Width?	N/A	
			N/A	Landing Curb? (Y/N)	N/A	N/A	DWS Offset (in)	N/A	
			N/A	Shared Landing?	N/A				
			N/A	Gutter Ponding?	N/A	N/A	Gutter Slope (%)	N/A	
			N/A	Gutter Lip Ht (in)	N/A	N/A	Gutter X Slope (%)	N/A	
			N/A	Painted X Walk1?	No	N/A	Painted X Walk2?	N/A	
				X Walk 1 Direction	To SW		X Walk 2 Direction	N/A	
				X Walk 1 Width (in)	N/A		X Walk 2 Width (in)	N/A	
				X Walk 1 Slope (%)	2.3		X Walk 2 Slope (%)	N/A	
				X Walk 1 X Slope (%)	4.0		X Walk 2 X Slope (%)	N/A	
			N/A	Ramp inside XWalk1?	N/A	N/A	Ramp inside XWalk2?	N/A	
				Road Slope (%)	4.0		Clear Space?	N/A	
				Road X Slope (%)	2.3	N/A	Clear Space to XWalk (in)	N/A	
						N/A	Any Obstruction?	N/A	
							Obstruction Type	N/A	
						N/A	Storm Grate/Utility Hazard?	N/A	
							Storm Grate/Utility Type	N/A	
			Yes	Surface Condition? (G/P)		Good			
				Curb Slope (%)		12.6			
<div><div>
