# Access Compliance Report

## Public Rights-of-Way

### (Curb Ramps)

Intersection ID: 16738	Main Street: BEVERLY_DR	Cross Street: SHERWOOD_AV	Location: NE
ADA ID: 8AC071AEDC52	Ramp Type: PerpDiag	Initial Pass/Fail: Fail	Overall Compliance: No
Severity Score: 33.75			
Codes/Mitigation Info/Possible Solution		Field Measurements/Component Compliance

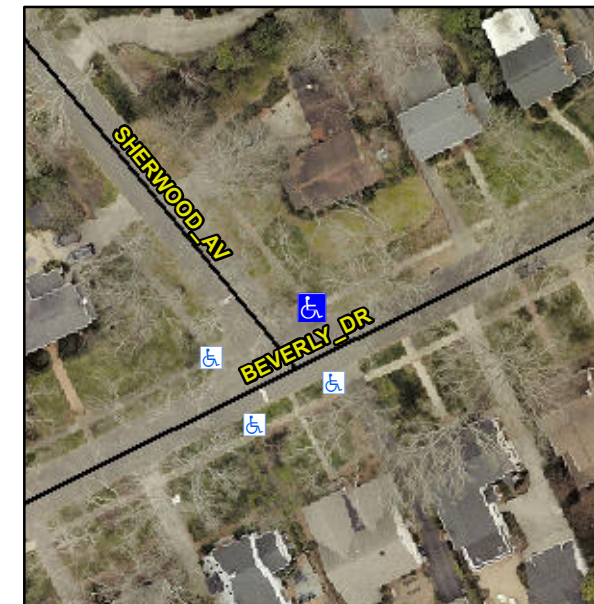
Compliance	Description	Data	Compliance	Description	Data
N/A	Ramp Length (in)	64.5	No	Ramp Slope (%)	11.0
No	Ramp Width (in)	43.5	No	Ramp XSlope (%)	5.6
N/A	Flare Type LT	N/A	N/A	Flare Type RT	N/A
N/A	Flare Slope LT (%)	N/A	N/A	Flare Slope RT (%)	N/A
N/A	Flare Traversable LT?	N/A	N/A	Flare Traversable RT?	N/A
N/A	Landing Length (in)	N/A	N/A	DWS Provided?	N/A
N/A	Landing Width (in)	N/A	N/A	DWS Contrast?	N/A
N/A	Landing Slope (%)	N/A	N/A	DWS Length (in)	N/A
N/A	Landing X Slope (%)	N/A	N/A	DWS Full Width?	N/A
N/A	Landing Curb? (Y/N)	N/A	N/A	DWS Offset (in)	N/A
N/A	Shared Landing?	N/A			
N/A	Gutter Ponding?	N/A	N/A	Gutter Slope (%)	N/A
N/A	Gutter Lip Ht (in)	N/A	N/A	Gutter X Slope (%)	N/A
N/A	Painted X Walk1?	No	N/A	Painted X Walk2?	No
	X Walk 1 Direction	To W		X Walk 2 Direction	To S
N/A	X Walk 1 Width (in)	N/A	N/A	X Walk 2 Width (in)	N/A
	X Walk 1 Slope (%)	2.5		X Walk 2 Slope (%)	2.2
	X Walk 1 X Slope (%)	4.0		X Walk 2 X Slope (%)	2.7

N/A	Ramp inside XWalk1?	N/A	N/A	Ramp inside XWalk2?	N/A
	Road Slope (%)	4.2	N/A	Clear Space?	N/A
	Road X Slope (%)	0.3	N/A	Clear Space to XWalk (in)	N/A
N/A	Any Obstructions?	N/A	N/A	Storm Grate/Utility Hazard?	N/A
	Obstruction Type			Storm Grate/Utility Type	
		N/A			N/A
		Yes		Surface Condition? (G/P)	Good

**Remove & Replace Curb Ramp With Two New Directional Ramps or Equivalent.**

**R304.5.1, R304.2.2, R304.5.3**
