## **Access Compliance Report Public Rights-of-Way** (Curb Ramps)

Intersection ID: 23437 Main Street: MOSS\_RD Cross Street: S\_TRYON\_ST Location: NE

**Overall Compliance: No ADA ID: 8ACD512BDDAD** Ramp Type: Perp Initial Pass/Fail: Fail Severity Score: 13.75

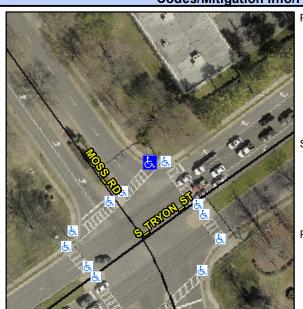
Field Measurements/Component Compliance								
Compl	iance Description	Data	Comp	liance Description	Data			
N/A	Ramp Length (in)	53.0	No	Ramp Slope (%)	9.1			
Yes	Ramp Width (in)	48.0	Yes Ramp XSlope (%)		2.5			
N/A	Flare Type LT	N/A	N/A Flare Type RT		N/A			
N/A	Flare Slope LT (%)	N/A	N/A Flare Slope RT (%)		N/A			
N/A	Flare Traversable LT?	N/A	N/A Flare Traversable RT?		N/A			
N/A	Landing Length (in)	N/A	N/A	DWS Provided?	N/A			
N/A	Landing Width (in)	N/A	N/A	DWS Contrast?	N/A			
N/A	Landing Slope (%)	N/A	N/A	DWS Length (in)	N/A			
N/A	Landing X Slope (%)	N/A	N/A	DWS Full Width?	N/A			
N/A	Landing Curb? (Y/N)	N/A	N/A	DWS Offset (in)	N/A			
N/A	Shared Landing?	N/A						
N/A	Gutter Ponding?	N/A	N/A	Gutter Slope (%)	N/A			
N/A	Gutter Lip Ht (in)	N/A	N/A	Gutter X Slope (%)	N/A			
N/A	Painted X Walk1?	Yes	N/A	Painted X Walk2?	N/A			
	X Walk 1 Direction	To W		X Walk 2 Direction	N/A			
N/A	X Walk 1 Width (in)	118.0	N/A	X Walk 2 Width (in)	N/A

X Walk 1 Slope (%)	0.6		X Walk 2 Slope (%)	N/A			
	X Walk 1 X Slope (%)	3.3		X Walk 2 X Slope (%)	N/A			
N/A	Ramp inside XWalk1?	Yes	N/A	Ramp inside XWalk2?	N/A			
	Road Slope (%)	N/A	N/A	Clear Space?	N/A			
	Road X Slope (%)	N/A	N/A	Clear Space to XWalk (in)	N/A			
N/A	Any Obstructions?	N/A	N/A	Storm Grate/Utility Hazard?	N/A			
	Obstruction Type			Storm Grate/Utility Type				
		N/A			N/A			
			Yes	Surface Condition? (G/P)	Good

Possible Solutions:					
Remove & Replace Entire Ramp.					
Surveyor Notes:					
N/A					
PROW/ADA:					
Not Found, R304.2.2					
Not Found, R304.2.2
