Access Compliance Report

Public Rights-of-Way

(Curb Ramps)

Intersection ID: 31234	Main Street: AVONLEA_CT	Cross Street: DAVID_COX_RD	Location: SE
ADA ID: 8ACFB8253861	Ramp Type: PerpDiag	Initial Pass/Fail: Fail	Overall Compliance: No
Severity Score: 1.25			
Codes/Mitigation Info/Possible Solution		Field Measurements/Component Compliance

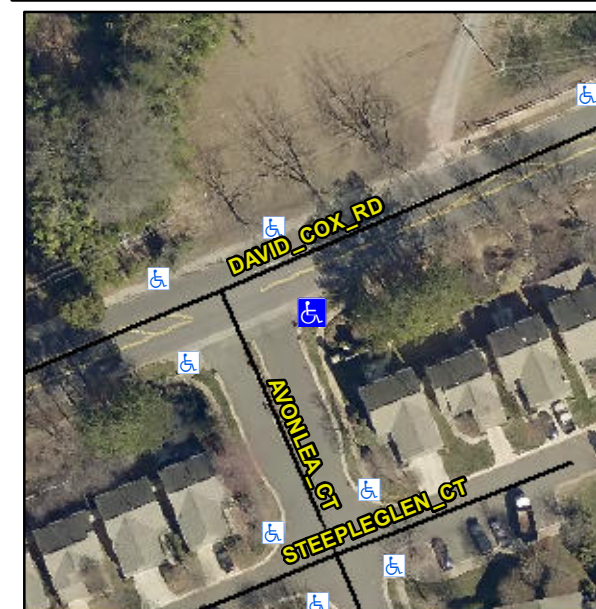
Not Found, R304.5.3

Compliance	Description	Data	Compliance	Description	Data
N/A	Ramp Length (in)	39.5	Yes	Ramp Slope (%)	6.6
Yes	Ramp Width (in)	48.0	No	Ramp XSlope (%)	2.4
N/A	Flare Type LT	N/A	N/A	Flare Type RT	N/A
N/A	Flare Slope LT (%)	N/A	N/A	Flare Slope RT (%)	N/A
N/A	Flare Traversable LT?	N/A	N/A	Flare Traversable RT?	N/A
N/A	Landing Length (in)	N/A	N/A	DWS Provided?	N/A
N/A	Landing Width (in)	N/A	N/A	DWS Contrast?	N/A
N/A	Landing Slope (%)	N/A	N/A	DWS Length (in)	N/A
N/A	Landing X Slope (%)	N/A	N/A	DWS Full Width?	N/A
N/A	Landing Curb? (Y/N)	N/A	N/A	DWS Offset (in)	N/A
N/A	Shared Landing?	N/A			
N/A	Gutter Ponding?	N/A	N/A	Gutter Slope (%)	N/A
N/A	Gutter Lip Ht (in)	N/A	N/A	Gutter X Slope (%)	N/A
N/A	Painted X Walk1?	No	N/A	Painted X Walk2?	No
	X Walk 1 Direction	To N		X Walk 2 Direction	To W
N/A	X Walk 1 Width (in)	N/A	N/A	X Walk 2 Width (in)	N/A
	X Walk 1 Slope (%)	0.7		X Walk 2 Slope (%)	1.4
	X Walk 1 X Slope (%)	0.6		X Walk 2 X Slope (%)	3.1

N/A	Ramp inside XWalk1?	N/A	N/A	Ramp inside XWalk2?	N/A
	Road Slope (%)	2.5	N/A	Clear Space?	N/A
	Road X Slope (%)	2.8	N/A	Clear Space to XWalk (in)	N/A
N/A	Any Obstructions?	N/A	N/A	Storm Grate/Utility Hazard?	N/A
	Obstruction Type			Storm Grate/Utility Type	
		N/A			N/A
		Yes		Surface Condition? (G/P)	Good

Remove & Replace Curb Ramp With Two New Directional Ramps or Equivalent.

Total Cost: \$ 3200.00
