Access Compliance Report

Public Rights-of-Way

(Curb Ramps)

| Intersection ID: 52698 | Main Street: JOSEPHINE_CT | Cross Street: N/A | Location: NE |

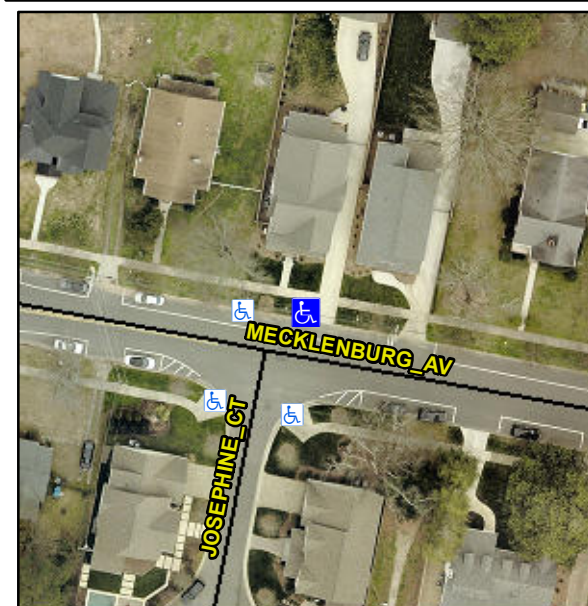
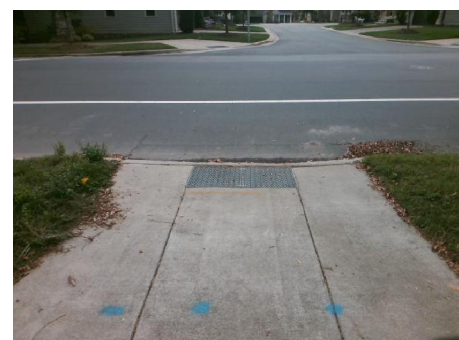
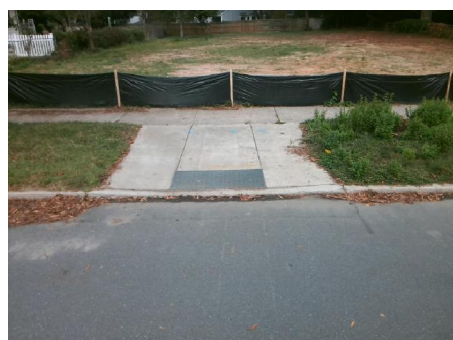
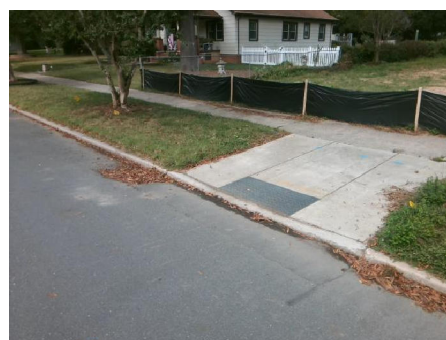
| ADA ID: 8ACFF55F7883 | Ramp Type: BlendTrans1 | Initial Pass/Fail: Fail | Overall Compliance: No |

| | | Severity Score: 8.75 | |

R304.5.1

| Compliance | Description | Data | Compliance | Description | Data |
|---|---|---|---|---|---|
| No | Ramp Width (in) | 47.0 | Yes | BlendTrans XSlope (%) | 1.5 |

Remove & Replace Curb Ramp With Two New Directional Ramps or Equivalent.
