Access Compliance Report

Public Rights-of-Way

(Curb Ramps)

Intersection ID: 43518	Main Street: ANDREW_COLTEN_CT	Cross Street: STONE_BLUFF_CT	Location: S
ADA ID: 8AD61446E257	Ramp Type: PerpDiag	Initial Pass/Fail: Fail	Overall Compliance: No
Severity Score: 8.75			
Codes/Mitigation Info/Possible Solution		Field Measurements/Component Compliance

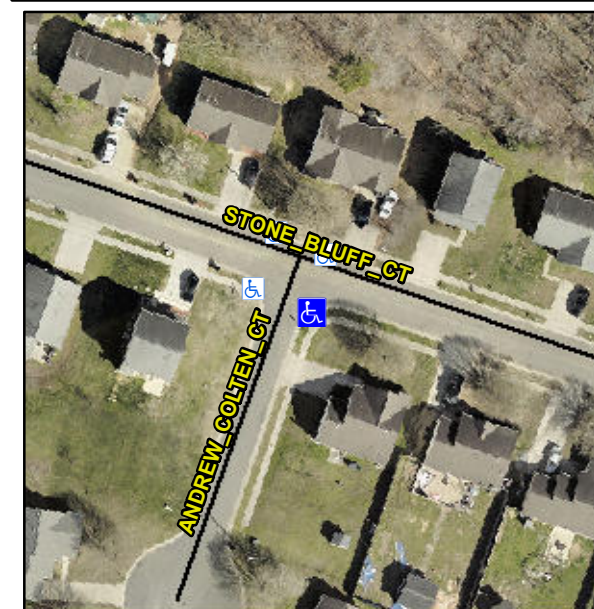
Not Found, R304.5.1

Compliance	Description	Data	Compliance	Description	Data
N/A	Ramp Length (in)	49.0	Yes	Ramp Slope (%)	5.7
No	Ramp Width (in)	45.0	Yes	Ramp XSlope (%)	0.3
N/A	Flare Type LT	N/A	N/A	Flare Type RT	N/A
N/A	Flare Slope LT (%)	N/A	N/A	Flare Slope RT (%)	N/A
N/A	Flare Traversable LT?	N/A	N/A	Flare Traversable RT?	N/A
N/A	Landing Length (in)	N/A	N/A	DWS Provided?	N/A
N/A	Landing Width (in)	N/A	N/A	DWS Contrast?	N/A
N/A	Landing Slope (%)	N/A	N/A	DWS Length (in)	N/A
N/A	Landing X Slope (%)	N/A	N/A	DWS Full Width?	N/A
N/A	Landing Curb? (Y/N)	N/A	N/A	DWS Offset (in)	N/A
N/A	Shared Landing?	N/A			
N/A	Gutter Ponding?	N/A	N/A	Gutter Slope (%)	N/A
N/A	Gutter Lip Ht (in)	N/A	N/A	Gutter X Slope (%)	N/A
N/A	Painted X Walk1?	No	N/A	Painted X Walk2?	No
	X Walk 1 Direction	To NE		X Walk 2 Direction	To NW
N/A	X Walk 1 Width (in)	N/A	N/A	X Walk 2 Width (in)	N/A
	X Walk 1 Slope (%)	4.3		X Walk 2 Slope (%)	4.5
	X Walk 1 X Slope (%)	4.4		X Walk 2 X Slope (%)	2.3

N/A	Ramp inside XWalk1?	N/A	N/A	Ramp inside XWalk2?	N/A
	Road Slope (%)	1.0	N/A	Clear Space?	N/A
	Road X Slope (%)	5.6	N/A	Clear Space to XWalk (in)	N/A
N/A	Any Obstructions?	N/A	N/A	Storm Grate/Utility Hazard?	N/A
	Obstruction Type			Storm Grate/Utility Type	
		N/A			N/A
			Yes	Surface Condition? (G/P)	Good

Remove & Replace Curb Ramp With Two New Directional Ramps or Equivalent.
