Access Compliance Report

Public Rights-of-Way

(Curb Ramps)

Intersection ID: 10035338	Main Street: RAIL_CROSSING_LN	Cross Street: N/A	Location: NE
ADA ID: 8AD7553E58C5	Ramp Type: Perp	Initial Pass/Fail: Fail	Overall Compliance: No
			Severity Score: 13.75

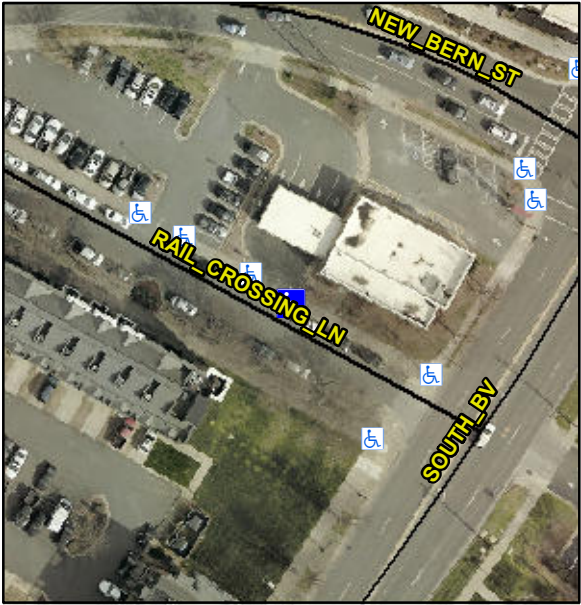
Possible Solutions:		Compliance	Description	Data
	Remove & Replace Entire Ramp.		N/A	Ramp Length (in)	66.0
			Yes	Ramp Width (in)	48.0
			N/A	Flare Type LT	N/A
			N/A	Flare Slope LT (%)	N/A
			N/A	Flare Traversable LT?	N/A
			N/A	Landing Length (in)	N/A
			N/A	Landing Width (in)	N/A
			N/A	Landing Slope (%)	N/A
			N/A	Landing X Slope (%)	N/A
<p>Surveyor Notes:</p> <p>N/A</p> <p>PROW/ADA:</p> <p>R304.2.2</p>			N/A	Flare Type RT	N/A
			N/A	Flare Slope RT (%)	N/A
			N/A	Flare Traversable RT?	N/A
			N/A	DWS Provided?	N/A
			N/A	DWS Contrast?	N/A
			N/A	DWS Length (in)	N/A
			N/A	DWS Full Width?	N/A
			N/A	DWS Offset (in)	N/A
			N/A	Shared Landing?	N/A
			N/A	Gutter Ponding?	N/A
			N/A	Gutter Lip Ht (in)	N/A
			N/A	Painted X Walk1?	No
				X Walk 1 Direction	To NW
			N/A	X Walk 1 Width (in)	N/A
				X Walk 1 Slope (%)	2.2
				X Walk 1 X Slope (%)	6.1

N/A	Ramp inside XWalk1?	N/A
				Road Slope (%)	N/A
				Road X Slope (%)	N/A
			N/A	Any Obstructions?	N/A
				Obstruction Type	
Total Cost:		\$ 1850.00
