Access Compliance Report Public Rights-of-Way (Curb Ramps)

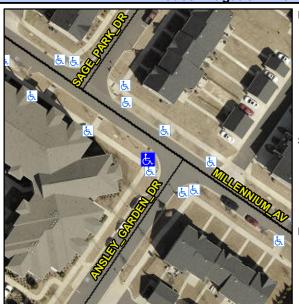
Intersection ID: N/A Main Street: MILLENNIUM_AV Cross Street: ANSLEY_GARDEN_DR Location: SW Ramp Type: Directional1 ADA ID: 8AD9AEBE0889 Initial Pass/Fail: Fail **Overall Compliance: No Severity Score:** 12.5

| - | Possible Solutions: |
|---|---|
| 8 | R304.2.2 |

| Field Measurements/Component Compliance | | | | | | | |
|---|---|---|---|---|---|--|--|
| No | Ramp Slope (%) | 8.6 | N/A | Grade Break XSlope (%) | 0.0 | | |

| - | Possible Solutions: |
|---|---|
| | Remove & Replace Entire Ramp. |
