Access Compliance Report

Public Rights-of-Way

(Curb Ramps)

Intersection ID: 15849	Main Street: NORTON_RD	Cross Street: QUEENS_RD_WEST	Location: SE
ADA ID: 8AE2C59B5C1E	Ramp Type: PerpDiag	Initial Pass/Fail: Fail	Overall Compliance: No
		Severity Score: 25

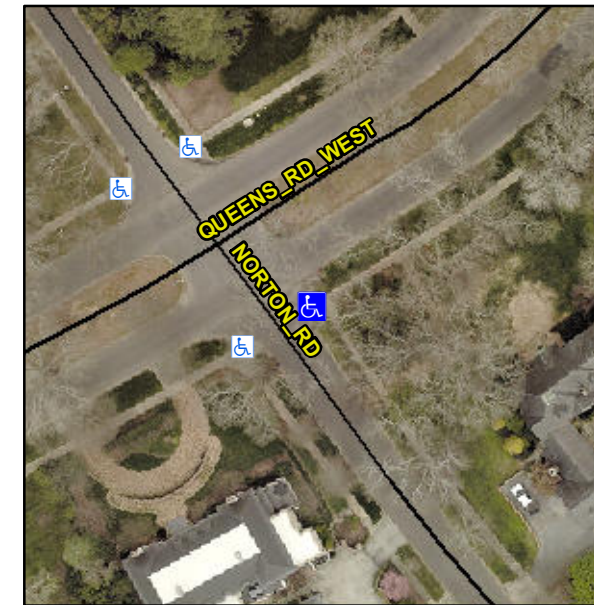
Not Found, R304.2.2, R304.5.3

Compliance	Description	Data	Compliance	Description	Data
N/A	Ramp Length (in)	78.0	No	Ramp Slope (%)	8.6
Yes	Ramp Width (in)	60.0	No	Ramp XSlope (%)	5.8
N/A	Flare Type LT	N/A	N/A	Flare Type RT	N/A
N/A	Flare Slope LT (%)	N/A	N/A	Flare Slope RT (%)	N/A
N/A	Flare Traversable LT?	N/A	N/A	Flare Traversable RT?	N/A
N/A	Landing Length (in)	N/A	N/A	DWS Provided?	N/A
N/A	Landing Width (in)	N/A	N/A	DWS Contrast?	N/A
N/A	Landing Slope (%)	N/A	N/A	DWS Length (in)	N/A
N/A	Landing X Slope (%)	N/A	N/A	DWS Full Width?	N/A
N/A	Landing Curb? (Y/N)	N/A	N/A	DWS Offset (in)	N/A
N/A	Shared Landing?	N/A			
N/A	Gutter Ponding?	N/A	N/A	Gutter Slope (%)	N/A
N/A	Gutter Lip Ht (in)	N/A	N/A	Gutter X Slope (%)	N/A
N/A	Painted X Walk1?	No	N/A	Painted X Walk2?	No
	X Walk 1 Direction	To NW		X Walk 2 Direction	To W
N/A	X Walk 1 Width (in)	N/A	N/A	X Walk 2 Width (in)	N/A
	X Walk 1 Slope (%)	0.9		X Walk 2 Slope (%)	2.9
	X Walk 1 X Slope (%)	0.0		X Walk 2 X Slope (%)	2.1

N/A	Ramp inside XWalk1?	N/A	N/A	Ramp inside XWalk2?	N/A
	Road Slope (%)	2.3	N/A	Clear Space?	N/A
	Road X Slope (%)	0.5	N/A	Clear Space to XWalk (in)	N/A
N/A	Any Obstructions?	N/A	N/A	Storm Grate/Utility Hazard?	N/A
	Obstruction Type			Storm Grate/Utility Type	
		N/A			N/A
		Yes		Surface Condition? (G/P)	Good

Possible Solutions:

Remove & Replace Curb Ramp With Two New Directional Ramps or Equivalent.
