Access Compliance Report Public Rights-of-Way (Curb Ramps)

Intersection ID: 24195 Main Street: PROVIDENCE_RD Cross Street: BEVERLY_CREST_BV Location: NW

ADA ID: 8AE32090D486 Ramp Type: Perp Initial Pass/Fail: Fail Overall Compliance: No Severity Score: 12.5

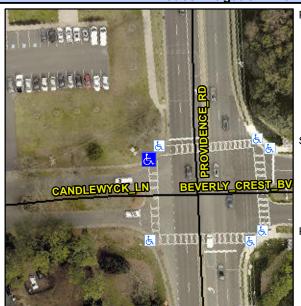
Field Measurements/Component Compliance							
	iance Description	Data	Comp	liance Description	Data		
N/A	Ramp Length (in)	71.0	No	Ramp Slope (%)	10.0		
Yes	Ramp Width (in)	76.0	Yes	Ramp XSlope (%)	0.8		
N/A	Flare Type LT	N/A	N/A	Flare Type RT	N/A		
N/A	Flare Slope LT (%)	N/A	N/A	Flare Slope RT (%)	N/A		
N/A	Flare Traversable LT?	N/A	N/A	Flare Traversable RT?	N/A		
N/A	Landing Length (in)	N/A	N/A	DWS Provided?	N/A		
N/A	Landing Width (in)	N/A	N/A	DWS Contrast?	N/A		
N/A	Landing Slope (%)	N/A	N/A	DWS Length (in)	N/A		
N/A	Landing X Slope (%)	N/A	N/A	DWS Full Width?	N/A		
N/A	Landing Curb? (Y/N)	N/A	N/A	DWS Offset (in)	N/A		
N/A	Shared Landing?	N/A					
N/A	Gutter Ponding?	N/A	N/A	Gutter Slope (%)	N/A		
N/A	Gutter Lip Ht (in)	N/A	N/A	Gutter X Slope (%)	N/A		
N/A	Painted X Walk1?	No	N/A	Painted X Walk2?	N/A		
	X Walk 1 Direction	To S		X Walk 2 Direction	N/A		
N/A	X Walk 1 Width (in)	N/A	N/A	X Walk 2 Width (in)	N/A

X Walk 1 Slope (%)	0.7		X Walk 2 Slope (%)	N/A		
	X Walk 1 X Slope (%)	0.1		X Walk 2 X Slope (%)	N/A		
N/A	Ramp inside XWalk1?	N/A	N/A	Ramp inside XWalk2?	N/A		
	Road Slope (%)	N/A	N/A	Clear Space?	N/A		
	Road X Slope (%)	N/A	N/A	Clear Space to XWalk (in)	N/A		
N/A	Any Obstructions?	N/A	N/A	Storm Grate/Utility Hazard?	N/A		
	Obstruction Type			Storm Grate/Utility Type			
		N/A			N/A		
			Yes	Surface Condition? (G/P)	Good		
	124 3 W	·	-

Possible Solution	
Possible Solutions:	Com
Remove & Replace Entire Ramp.	N/A
	Yes
	N/A
	N/A
	N/A
	N/A
Surveyor Notes:	N/A
N/A	N/A
	N/A
	N/A
	N/A
PROW/ADA:	N/A
Not Found, R304.2.2	N/A
	N/A
	N/A
	N/A
