## **Access Compliance Report Public Rights-of-Way** (Curb Ramps)

Intersection ID: 15083 Main Street: SHEFFIELD DR **Cross Street: WOODLAND DR** Location: SE ADA ID: 8AE96AD6C41F Ramp Type: BlendTrans1 Initial Pass/Fail: Fail **Overall Compliance: No Severity Score:** 12.5

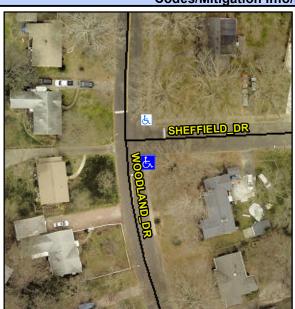
SHEFFIELD DR Street 1 Name Stop Condition-Street 1 StopSign Street 2 Name N/A Stop Condition-Street 2 N/A Possible Solutions: Remove & Replace Curb Ramp With Two New Directional Ramps or Equivalent. Surveyor Notes: **NO LT SW**

Not Found, R304.5.3

Field Measurements/Component Compliance					
Compliance Description		Data	Compliance Description		Data
N/A	Ramp Length (in)	57.0	Yes	BlendTrans Slope (%)	2.6
Yes	Ramp Width (in)	48.0	No	BlendTrans XSlope (%)	5.3
N/A	Flare Type LT	N/A	N/A	Flare Type RT	N/A
N/A	Flare Slope LT (%)	N/A	N/A	Flare Slope RT (%)	N/A
N/A	Flare Traversable LT?	N/A	N/A	Flare Traversable RT?	N/A
N/A	Landing Length (in)	N/A	N/A	DWS Provided?	N/A
N/A	Landing Width (in)	N/A	N/A	DWS Contrast?	N/A
N/A	Landing Slope (%)	N/A	N/A	DWS Length (in)	N/A
N/A	Landing X Slope (%)	N/A	N/A	DWS Full Width?	N/A
N/A	Landing Curb? (Y/N)	N/A	N/A	DWS Offset (in)	N/A
N/A	Shared Landing?	N/A			
N/A	Gutter Ponding?	N/A	N/A	Gutter Slope (%)	N/A
N/A	Gutter Lip Ht (in)	N/A	N/A	Gutter X Slope (%)	N/A
N/A	Painted X Walk1?	No	N/A	Painted X Walk2?	N/A
	X Walk 1 Direction	To N		X Walk 2 Direction	N/A
	X Walk 1 Width (in)	N/A		X Walk 2 Width (in)	N/A
	X Walk 1 Slope (%)	8.6		X Walk 2 Slope (%)	N/A

X Walk 1 X Slope (%)	2.6		X Walk 2 X Slope (%)	N/A
N/A	Ramp inside XWalk1?	N/A	N/A	Ramp inside XWalk2?	N/A
	Road Slope (%)	2.6		Clear Space?	N/A
	Road X Slope (%)	8.6	N/A	Clear Space to XWalk (in)	N/A
N/A	Any Obstructions?	N/A	N/A	Storm Grate/Utility Hazard?	N/A
	Obstruction Type			Storm Grate/Utility Type	
		N/A			N/A
			Yes	Surface Condition? (G/P)	Good

-			No	Curb Slope (%)	12.4
