# Access Compliance Report

## Public Rights-of-Way

### (Curb Ramps)

Intersection ID: N/A	Main Street: DALLAS_BAY_RD	Cross Street: HAMILTON_BRIDGE_RD	Location: NW
ADA ID: 8AEE1A054E7A	Ramp Type: Perp	Initial Pass/Fail: Fail	Overall Compliance: No
			Severity Score: 21.25

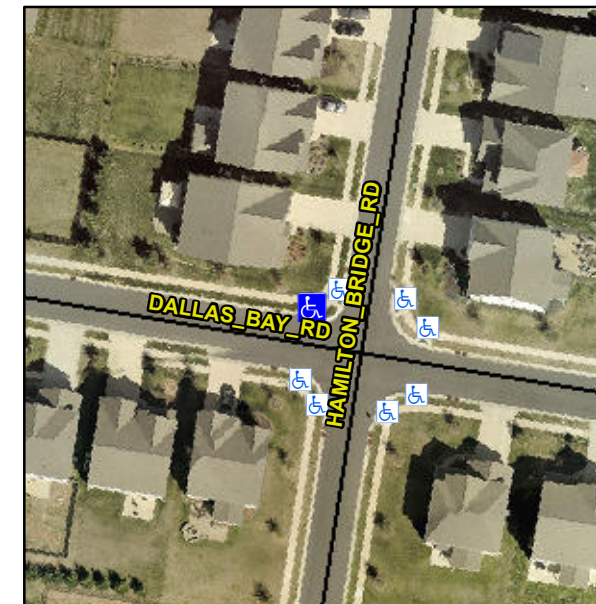
**Not Found, R304.5.1, R304.2.2**

Compliance	Description	Data	Compliance	Description	Data
N/A	Ramp Length (in)	47.0	No	Ramp Slope (%)	9.1
No	Ramp Width (in)	47.0	Yes	Ramp XSlope (%)	0.5
N/A	Flare Type LT	N/A	N/A	Flare Type RT	N/A
N/A	Flare Slope LT (%)	N/A	N/A	Flare Slope RT (%)	N/A
N/A	Flare Traversable LT?	N/A	N/A	Flare Traversable RT?	N/A
N/A	Landing Length (in)	N/A	N/A	DWS Provided?	N/A
N/A	Landing Width (in)	N/A	N/A	DWS Contrast?	N/A
N/A	Landing Slope (%)	N/A	N/A	DWS Length (in)	N/A
N/A	Landing X Slope (%)	N/A	N/A	DWS Full Width?	N/A
N/A	Landing Curb? (Y/N)	N/A	N/A	DWS Offset (in)	N/A
N/A	Shared Landing?	N/A			
N/A	Gutter Ponding?	N/A	N/A	Gutter Slope (%)	N/A
N/A	Gutter Lip Ht (in)	0.5	N/A	Gutter X Slope (%)	N/A
N/A	Painted X Walk1?	No	N/A	Painted X Walk2?	N/A
	X Walk 1 Direction	To SW		X Walk 2 Direction	N/A
N/A	X Walk 1 Width (in)	N/A	N/A	X Walk 2 Width (in)	N/A
	X Walk 1 Slope (%)	1.6		X Walk 2 Slope (%)	N/A
	X Walk 1 X Slope (%)	1.2		X Walk 2 X Slope (%)	N/A

N/A	Ramp inside XWalk1?	N/A	N/A	Ramp inside XWalk2?	N/A
	Road Slope (%)	N/A	N/A	Clear Space?	N/A
	Road X Slope (%)	N/A	N/A	Clear Space to XWalk (in)	N/A
N/A	Any Obstructions?	N/A	N/A	Storm Grate/Utility Hazard?	N/A
	Obstruction Type			Storm Grate/Utility Type	
		N/A			N/A
			Yes	Surface Condition? (G/P)	Good

**Remove & Replace Entire Ramp.**

Total Cost: \$ 1850.00
